**ASBESTOS CONTAINING MATERIALS, LEAD-BASED PAINT and MOLD SURVEY**

**KING FARM FARMSTEAD PROPERTY  
16100 FREDERICK ROAD  
ROCKVILLE, MD**

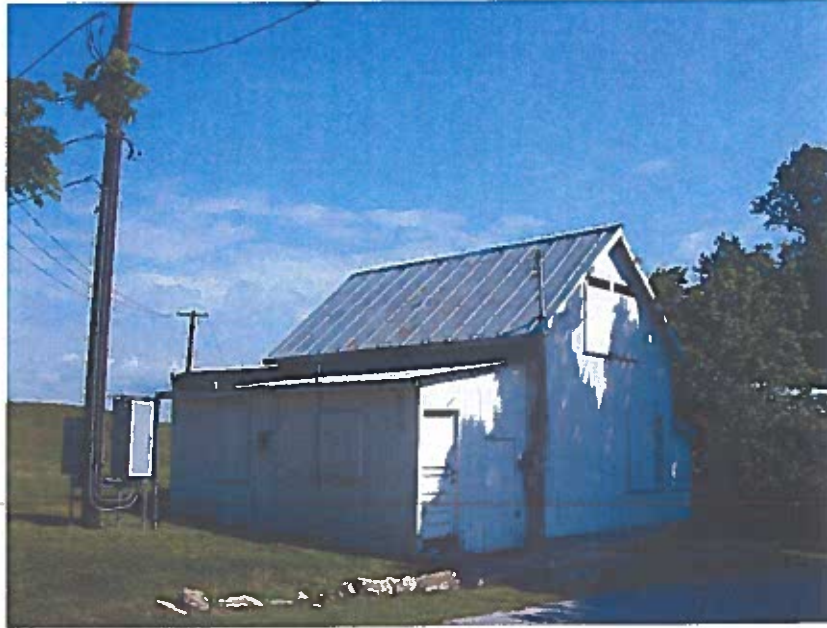
Photo 1: Overall view of building.

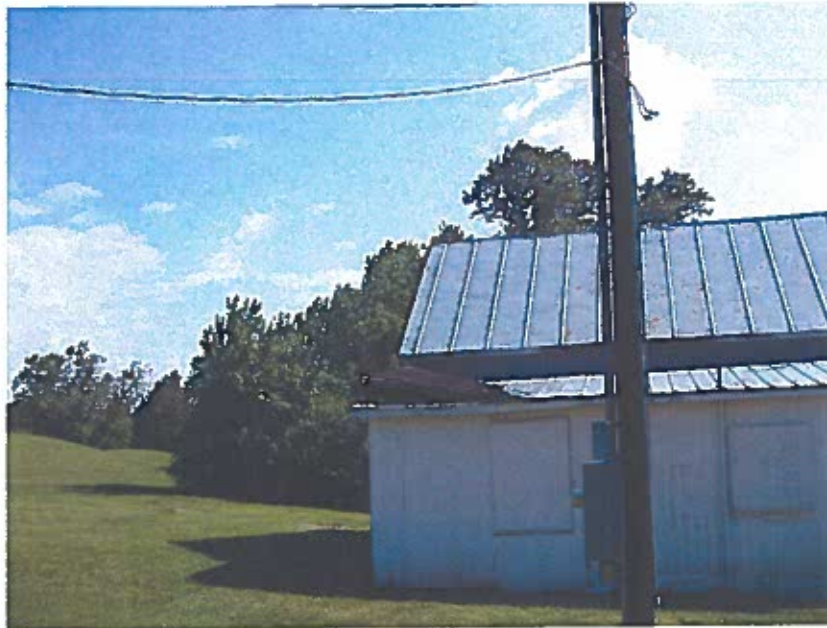
Photo 2: Close up view of roof. Note poor condition of BUR.

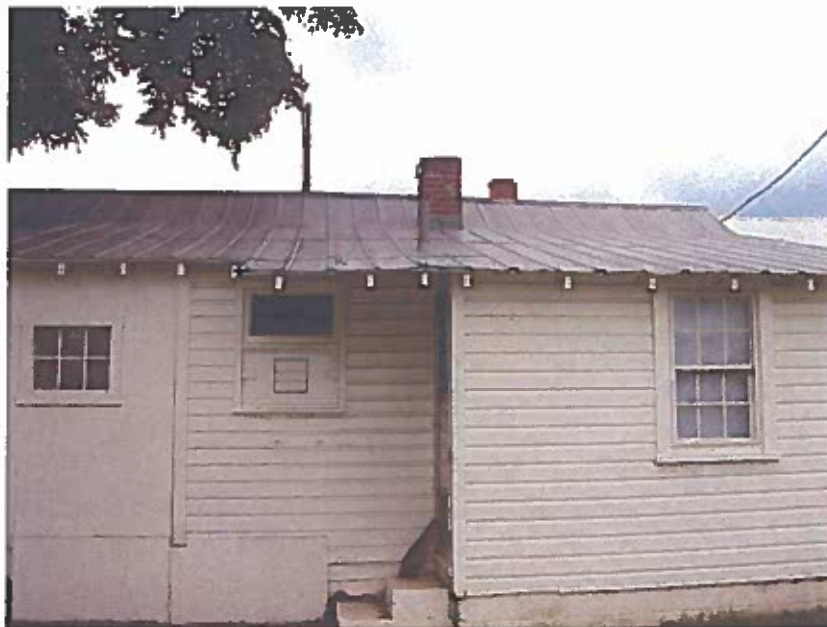
Photo 2: Close up view of roof. Note covered chimney and general condition of roof coating.

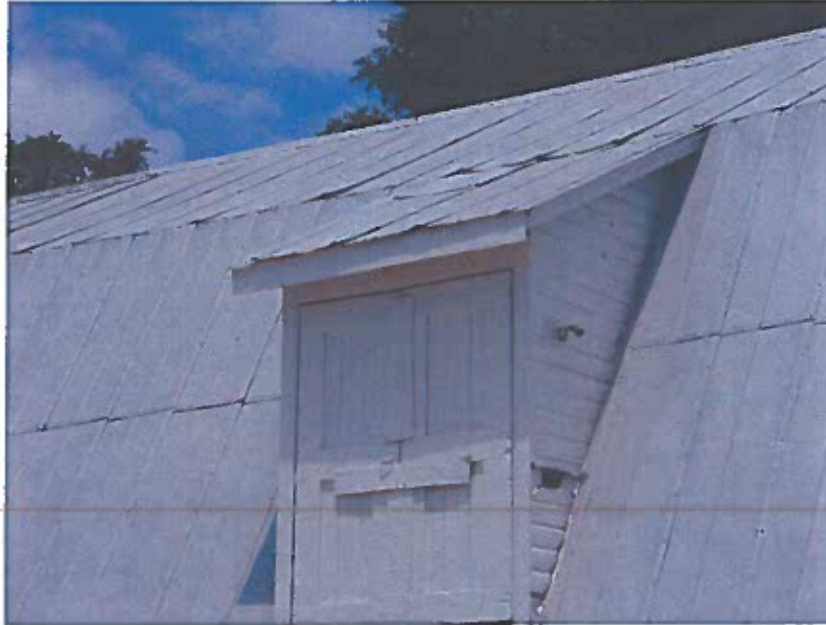
Photo 1: View of roof. Note unattached roof panels

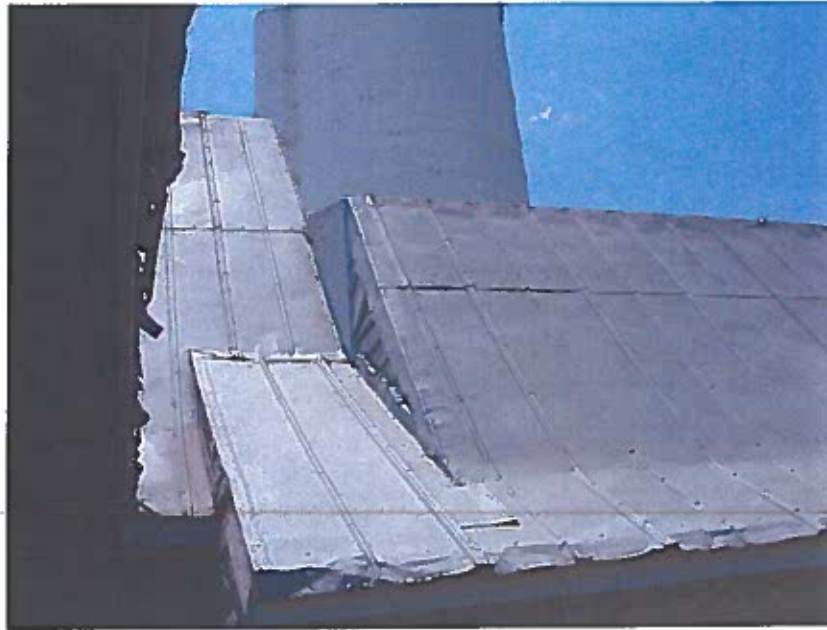
Photo 1: View of roof. Note bent roof panels

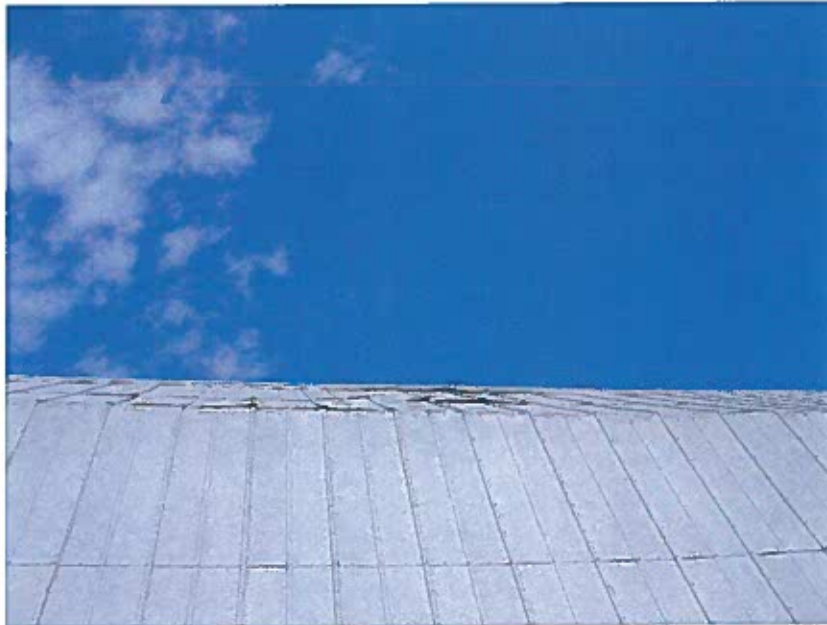
Photo 2: View of roof. Note loose roof panels.

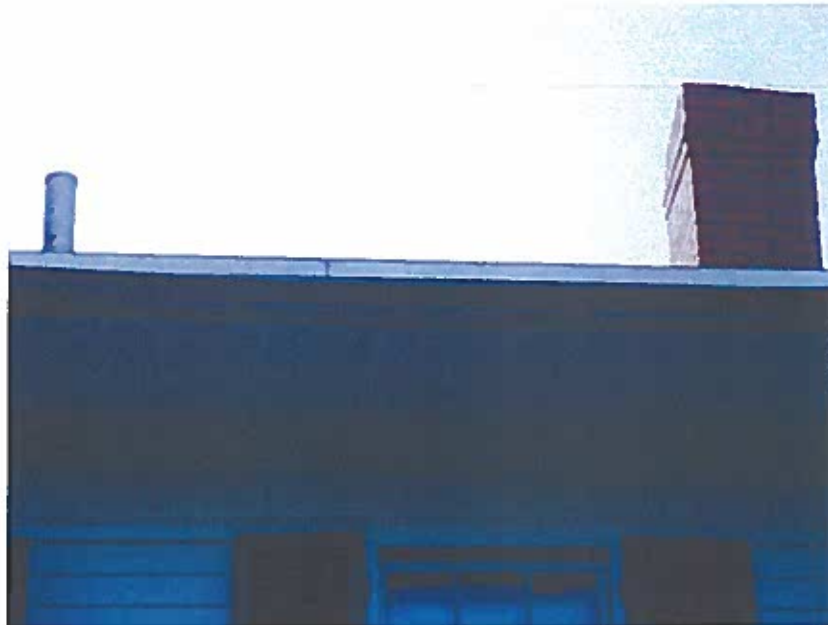
Photo 2: Close up view of roof. Note loose gutter.

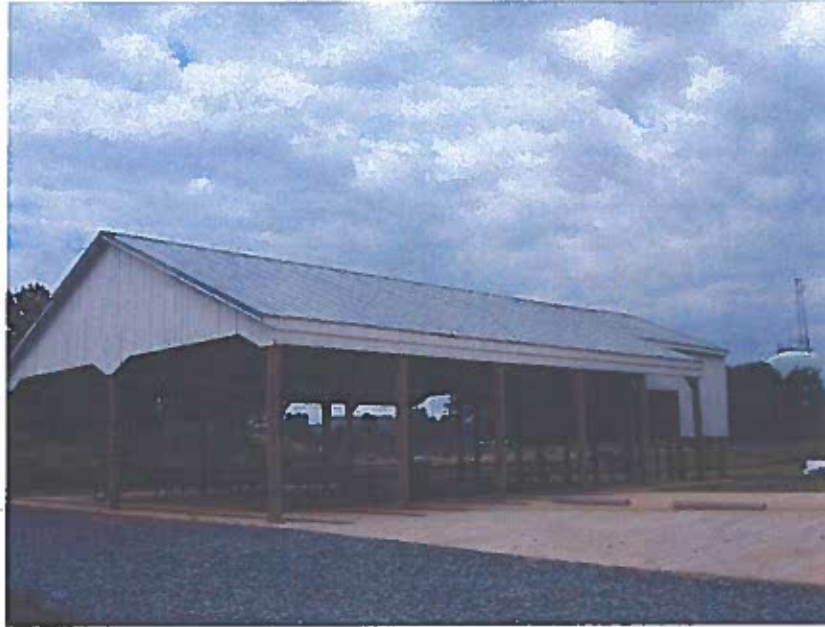
Photo 1: Overall view of building.

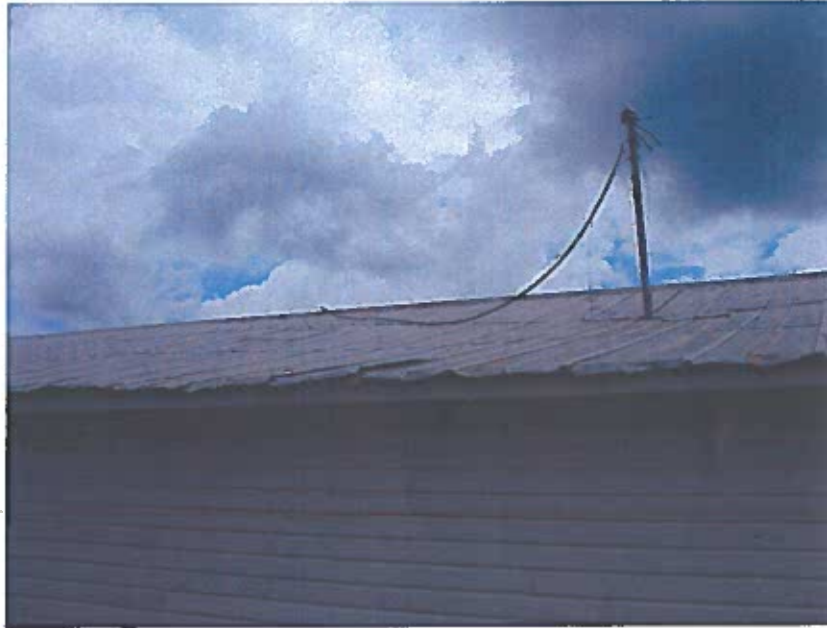
Photo 1: View of roof. Note loose roof panels and belly in roof.

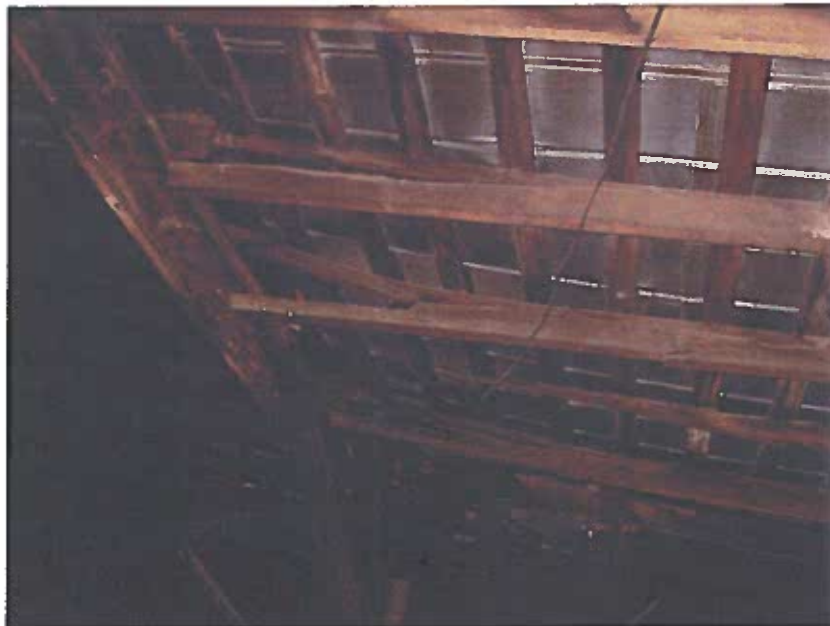
Photo 2: Interior of building. Note broken structural supports

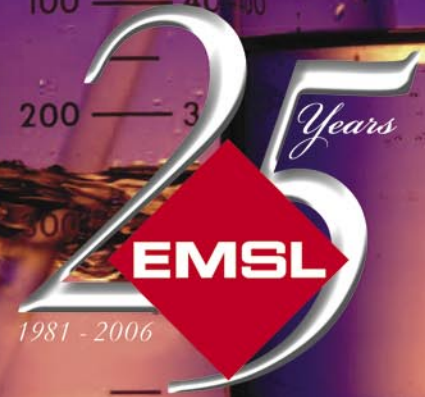
Laboratory Testing Services Since 1981

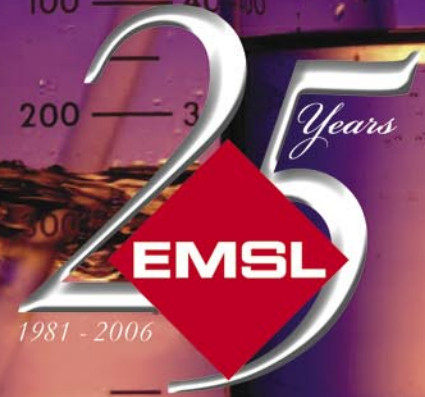
Laboratory Testing Services Since 1981

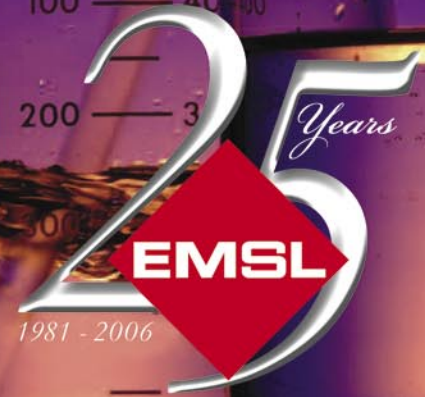
Laboratory Testing Services Since 1981
