City of Rockville
Department of Public Works
Parks and Facilities Division

2018 BRIDGE INSPECTION REPORT
October 2, 2018

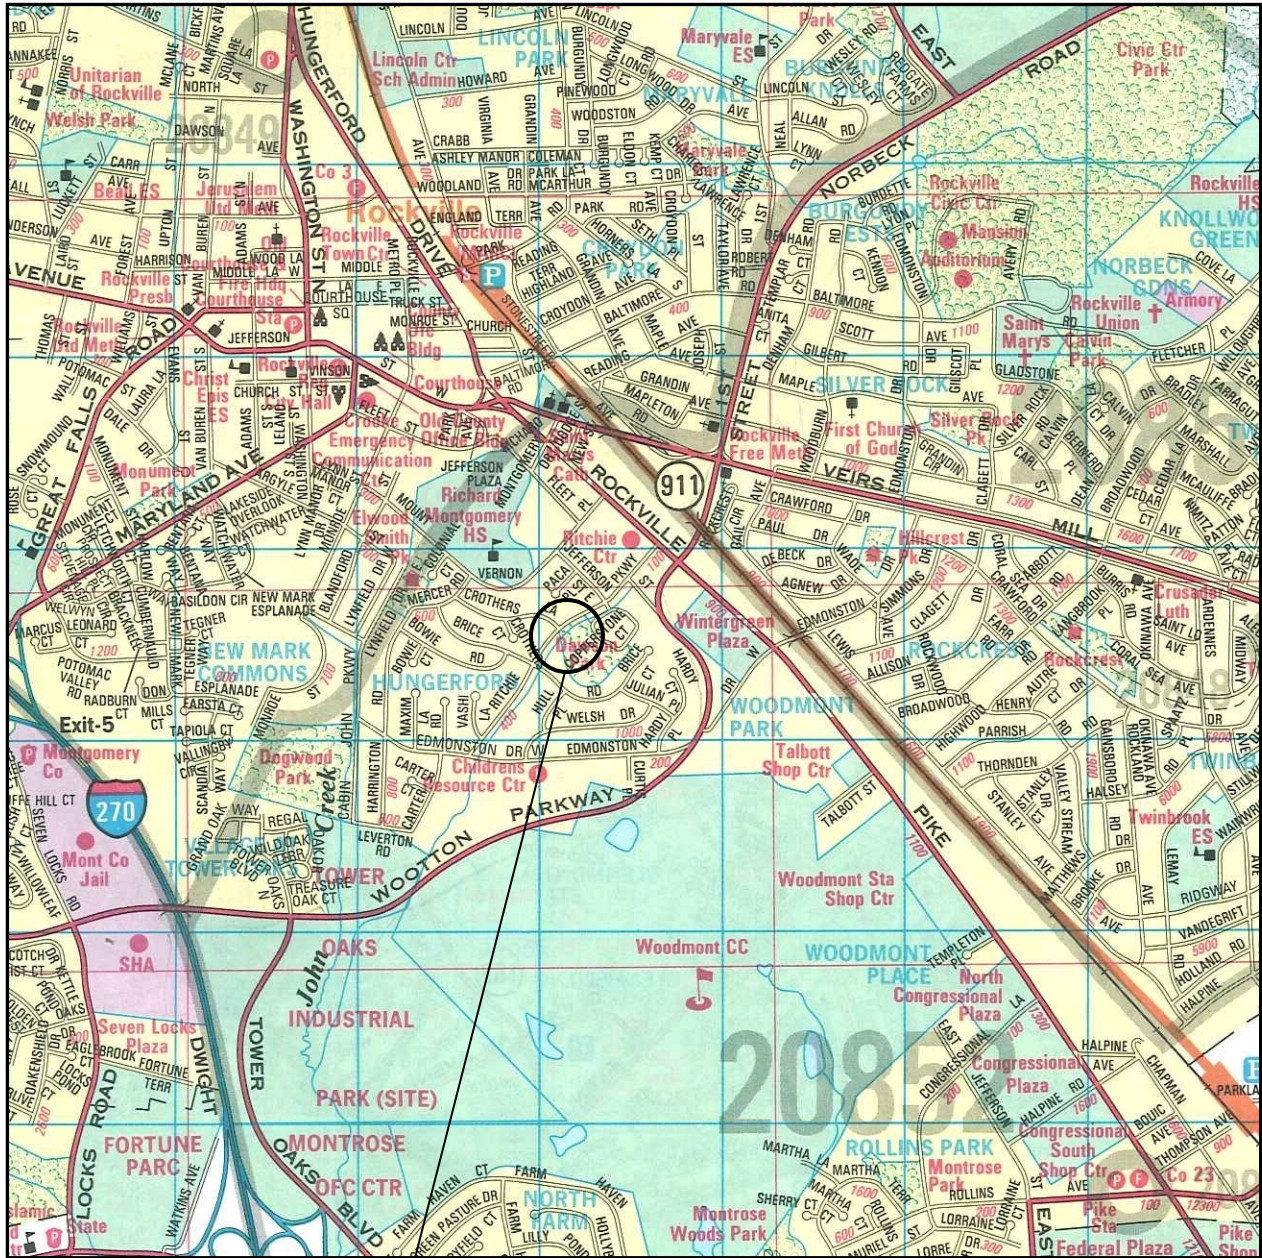
Structure No. PB-065
 Dawson Farm Park
 Pedestrian Bridge over
 Tributary to
 Cabin John Creek

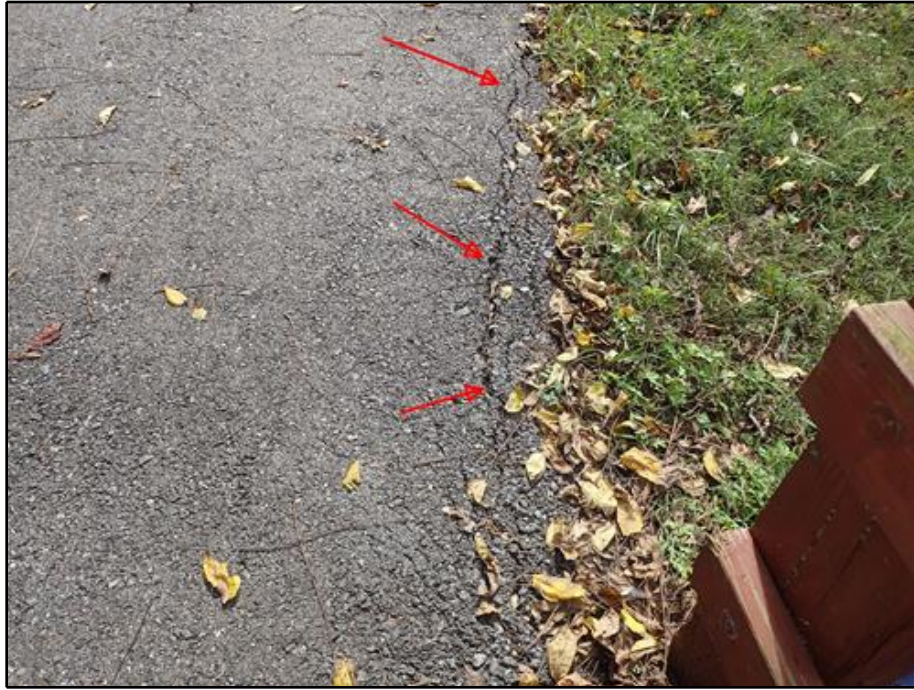
7. East Approach - 8 ft. Long x Up to 1/4 in. Open Crack in South Edge of Pavement

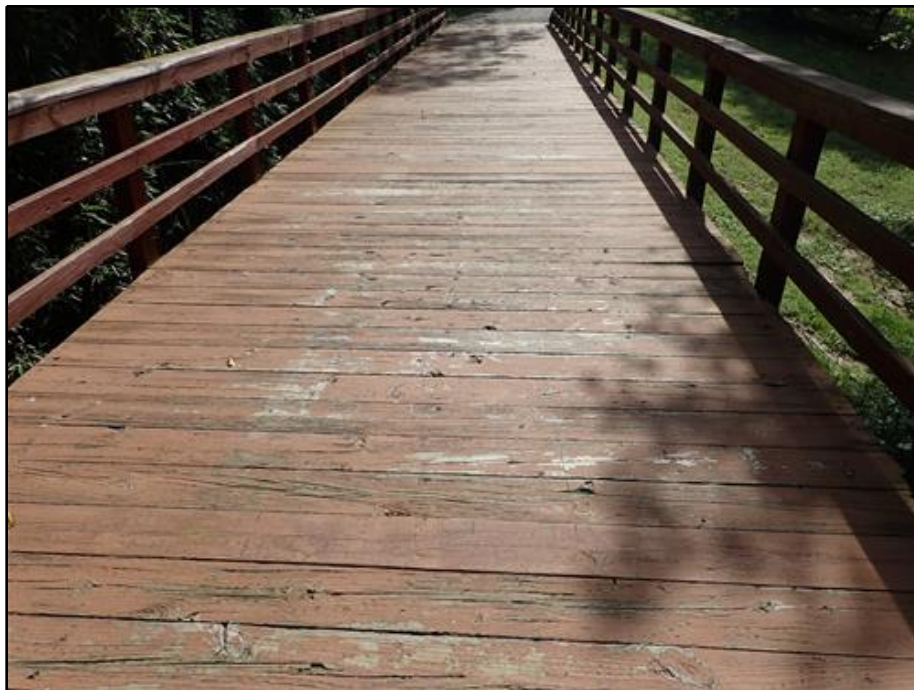
8. Overall Deck Surface

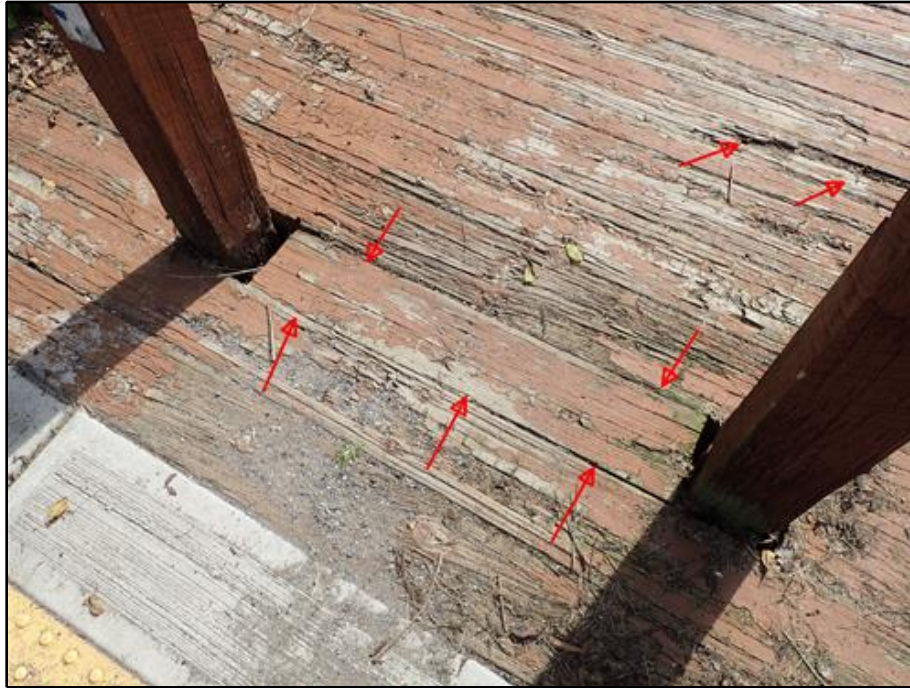
9. Span 1 - 3'-11" Long Loose Board Between Posts Near West Approach

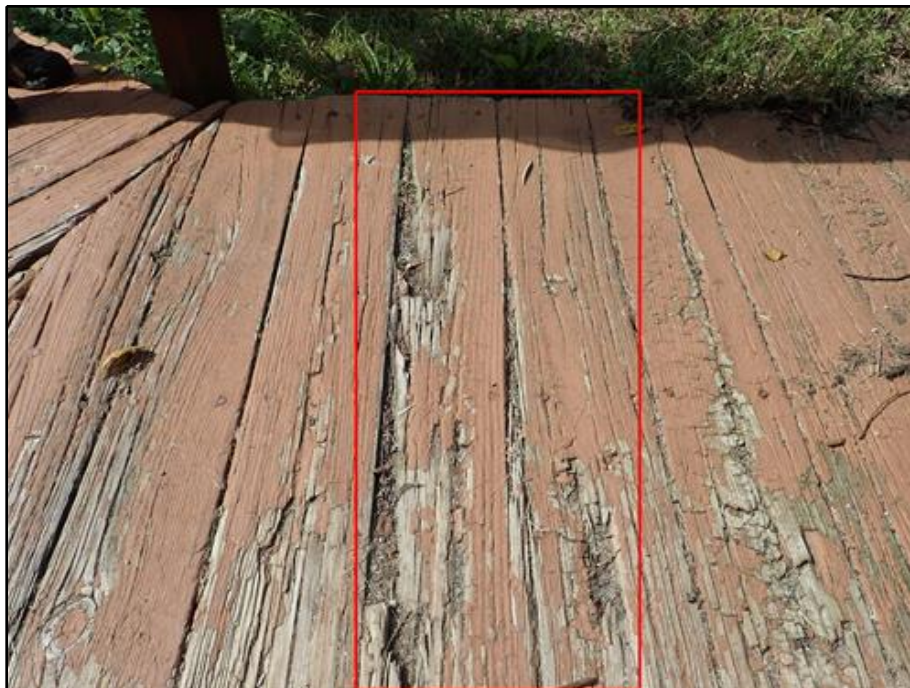
10. Span 1, Plank 7 - 6 ft. Long Area of Decay with Splintering and 1" Pick Penetrations

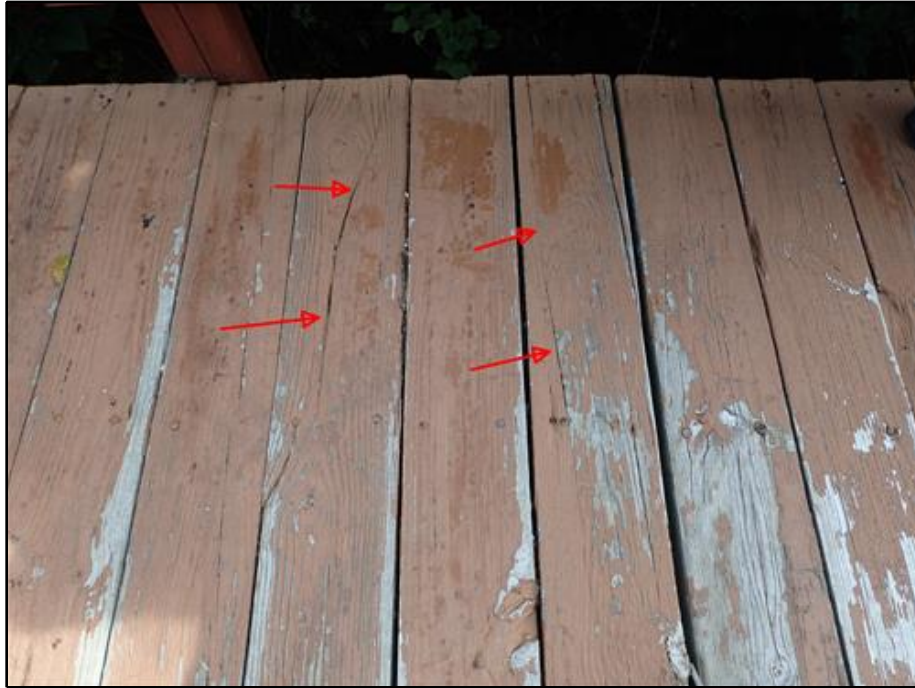
11. Span 2 - 1/16" Open Checks in Planks 8 and 10

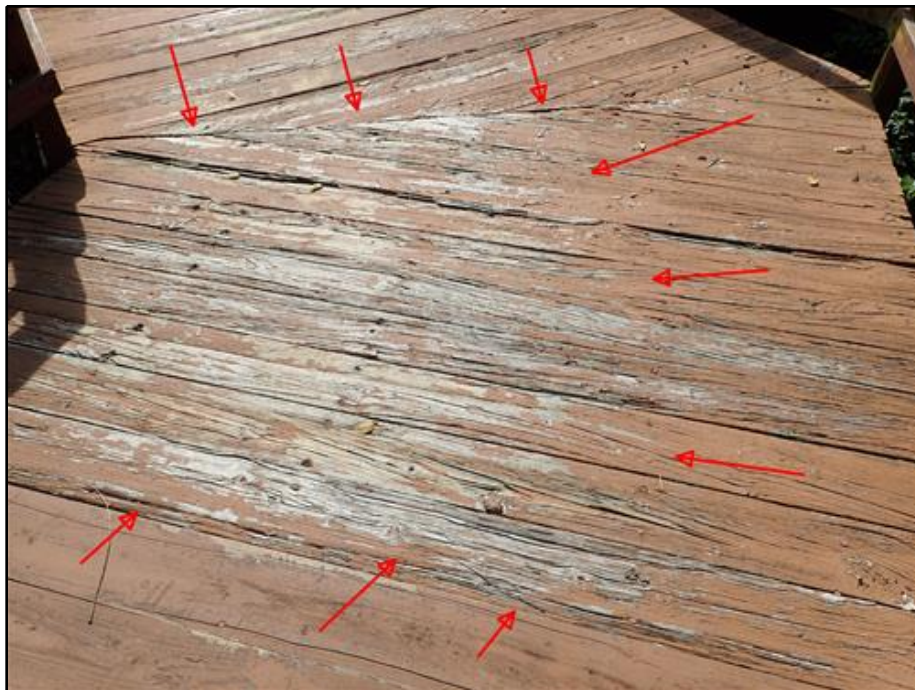
12. Heavier Wear on Deck Surface in Span 3

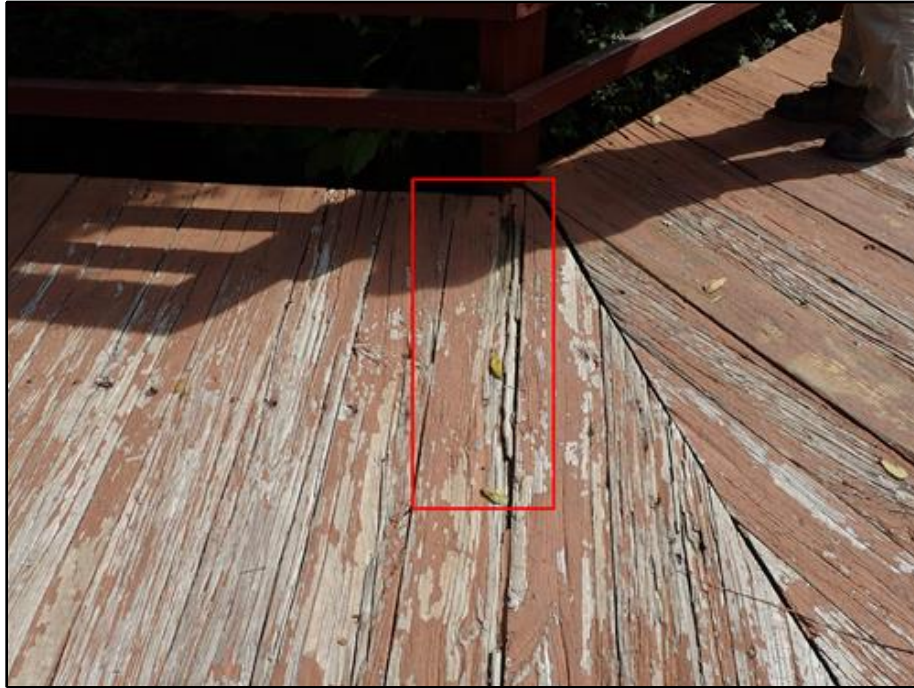
13. Span 3, Plank 14 - Full Length of Decay with 3/4 in. Pick Penetrations;
Plank is also Loose

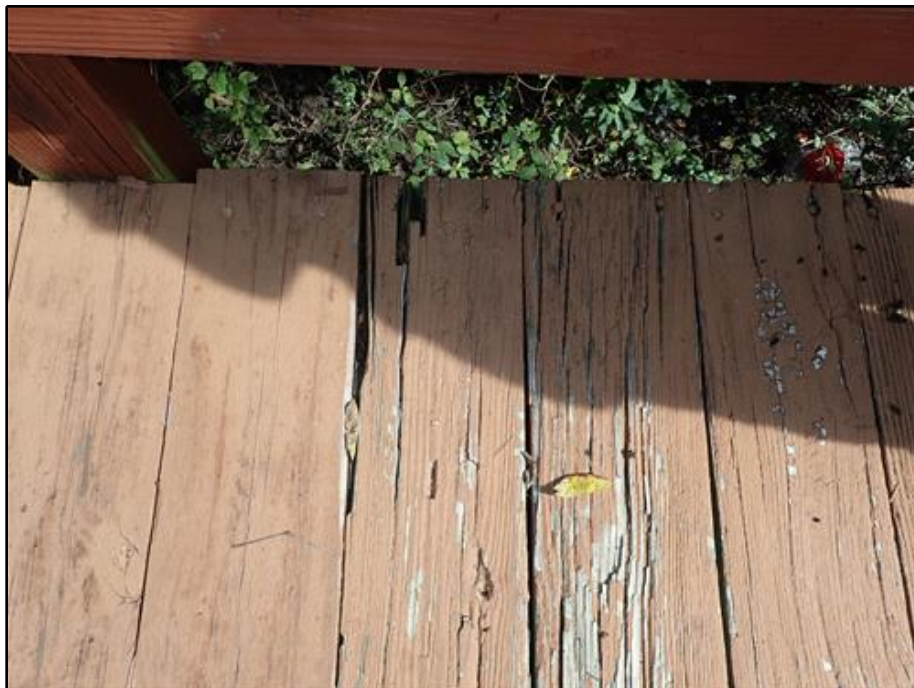
14. Span 5, Plank 2 - 1 ft. 4 in. Wide x 4 in. Long Area of Rot/Decay with 3/4 in.
Pick Penetrations

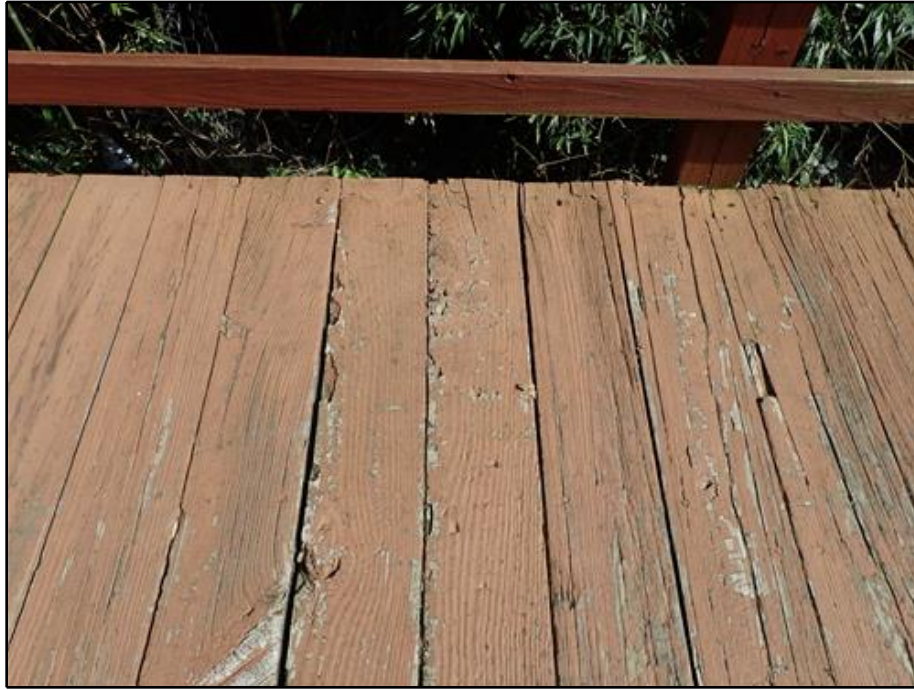
15. Span 10 - Decay in Planks 13 and 14 with 3/4" Pick Penetrations (Full Width)

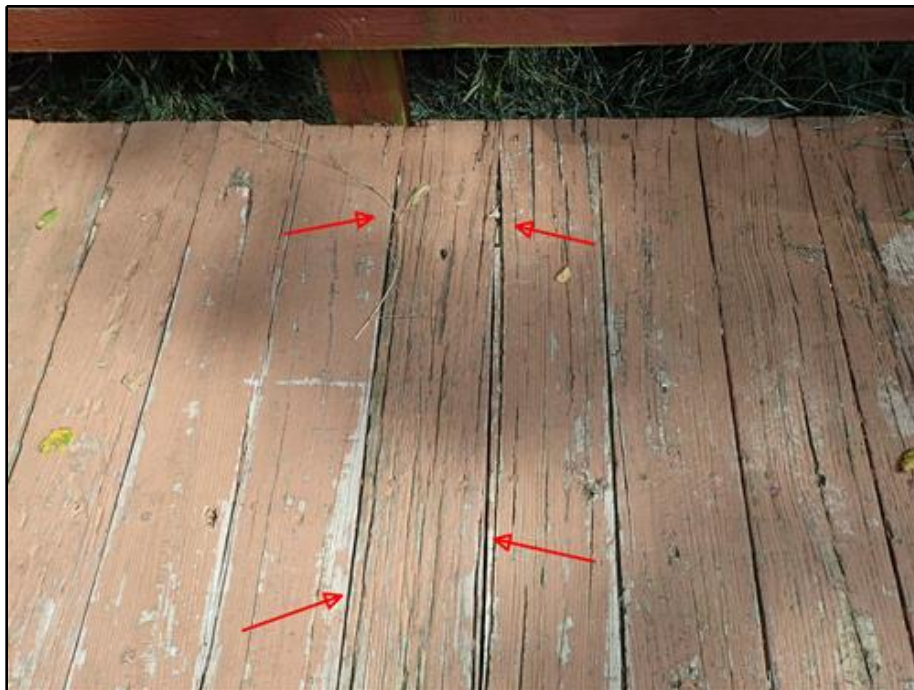
16. Span 11, Plank 1 - 4 ft. Wide Rot/Decay with 3/4" Pick Penetration

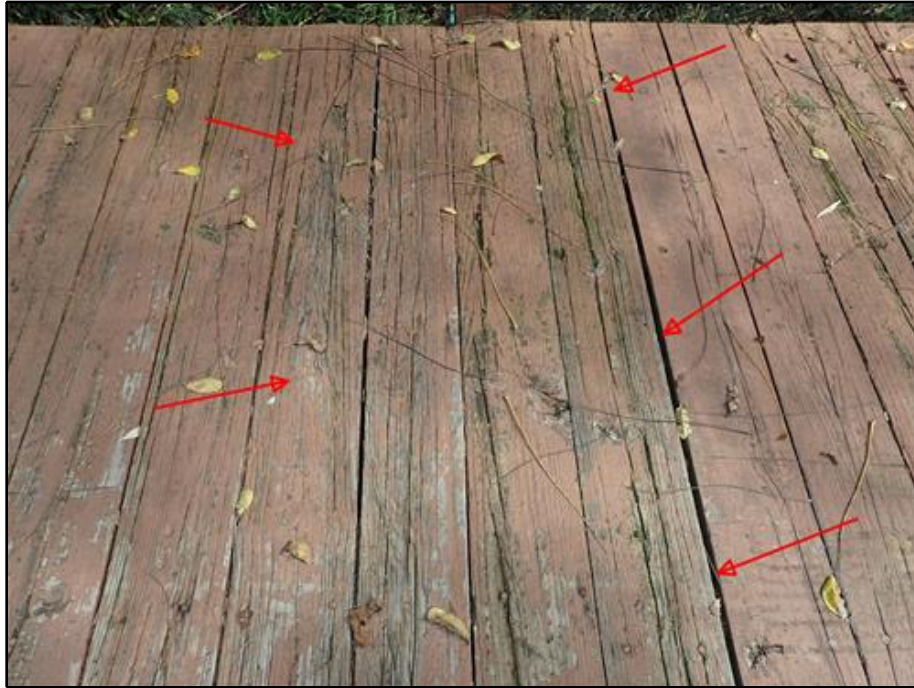
19. Spans 13 and 14, Decay in Planks with 1 in. Pick Penetration for a 3 ft. Width

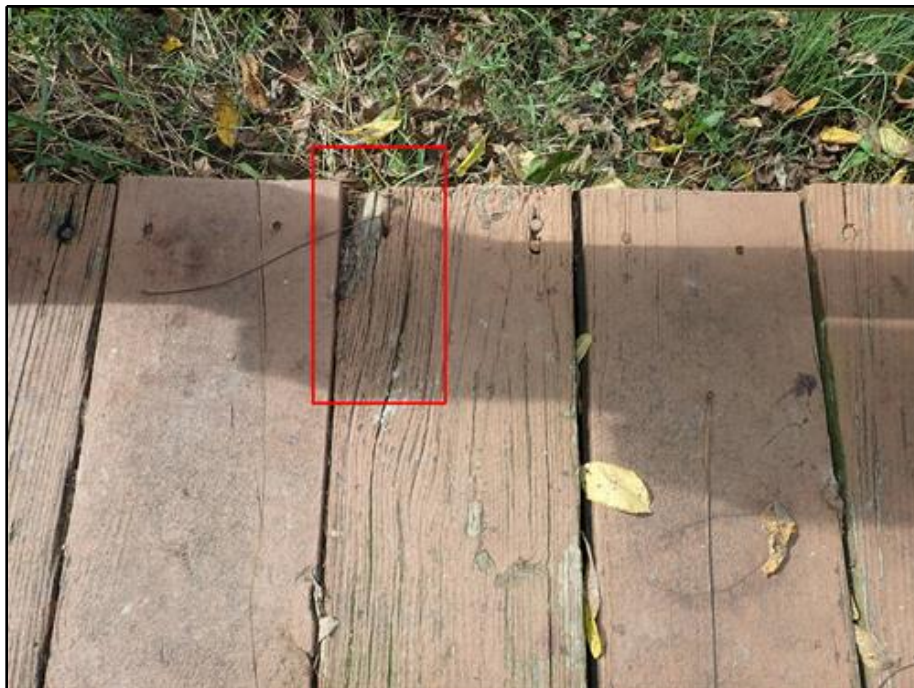
20. Span 14, Plank 13, South End - 3 in. Edge Splintering

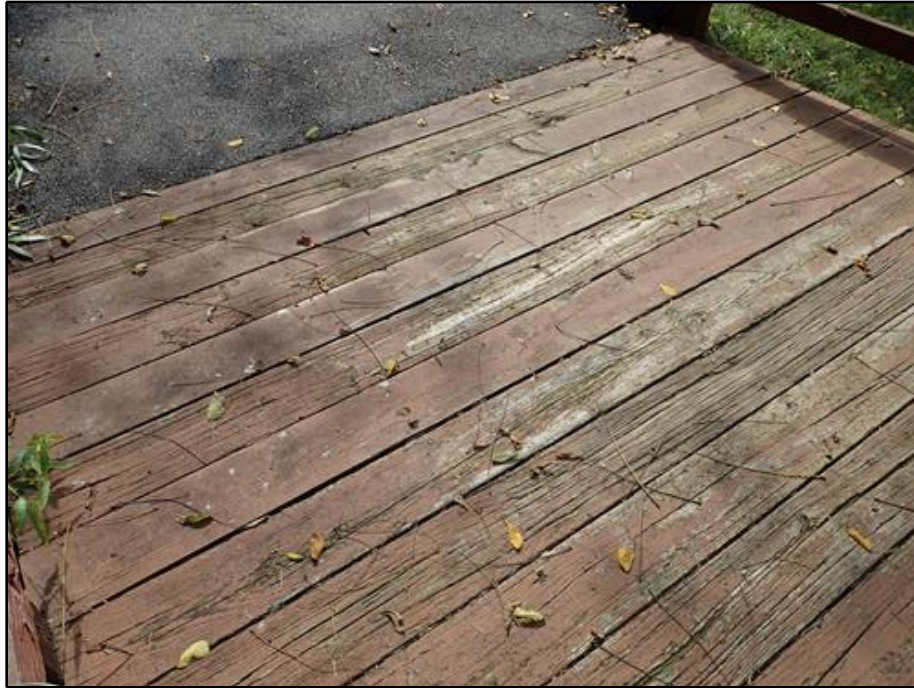
21. Span 14, Nine (9) Decayed Planks with Up to 1 in. Pick Penetrations

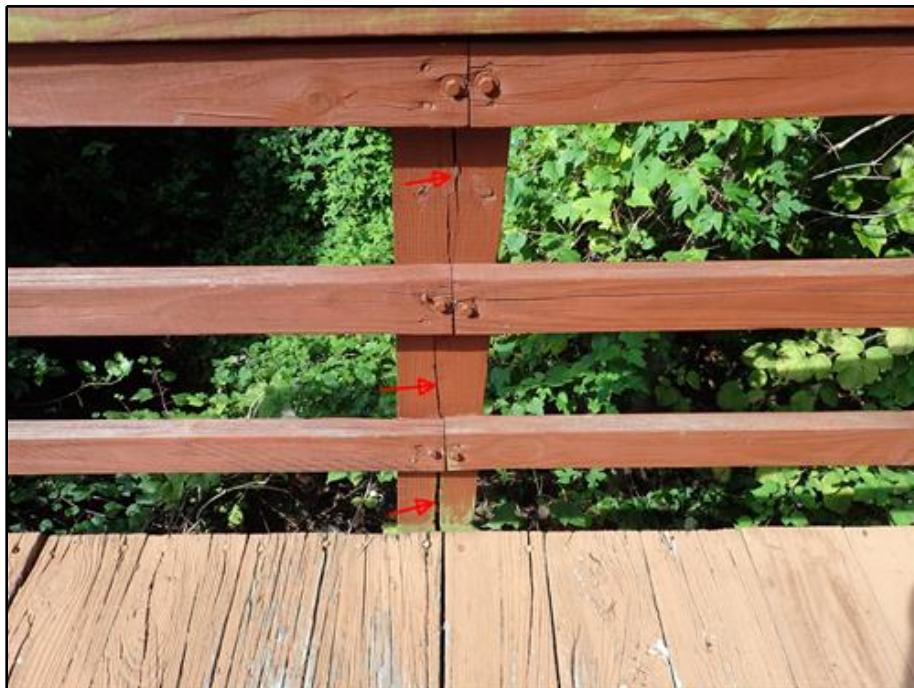
22. Typical Split at Post Connection - Span 3, Post 2

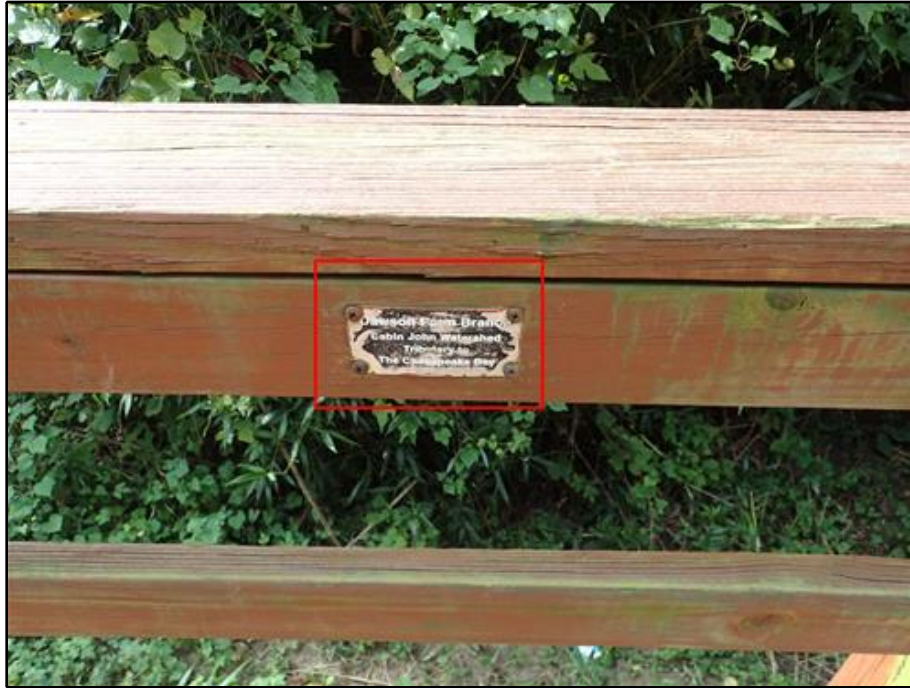
27. Worn Stream Name Plaque at South Railing

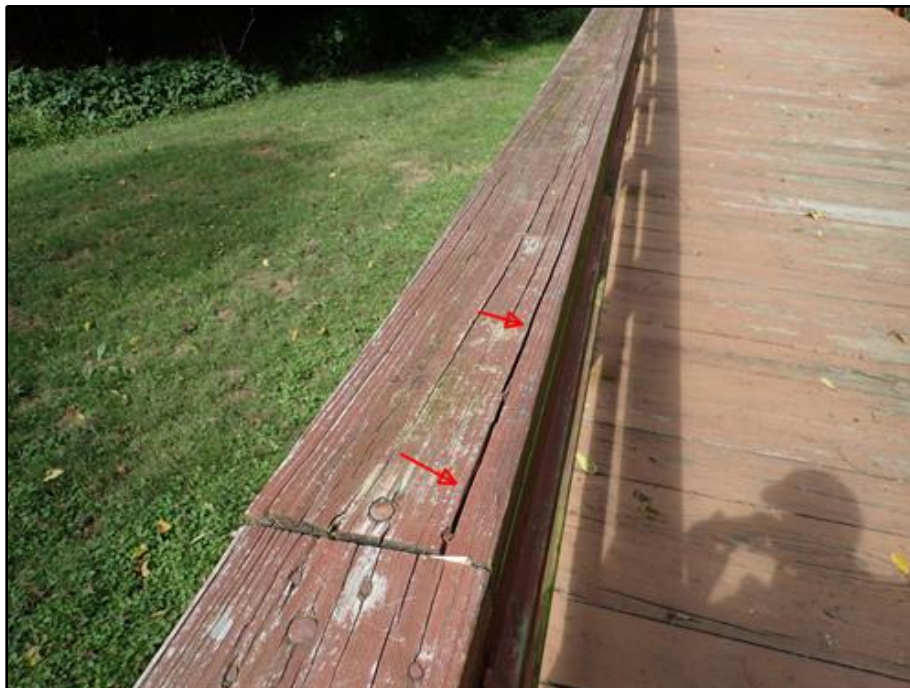
28. Typical, Up to 1/8 in. Open Checks in Top Cap of Railing

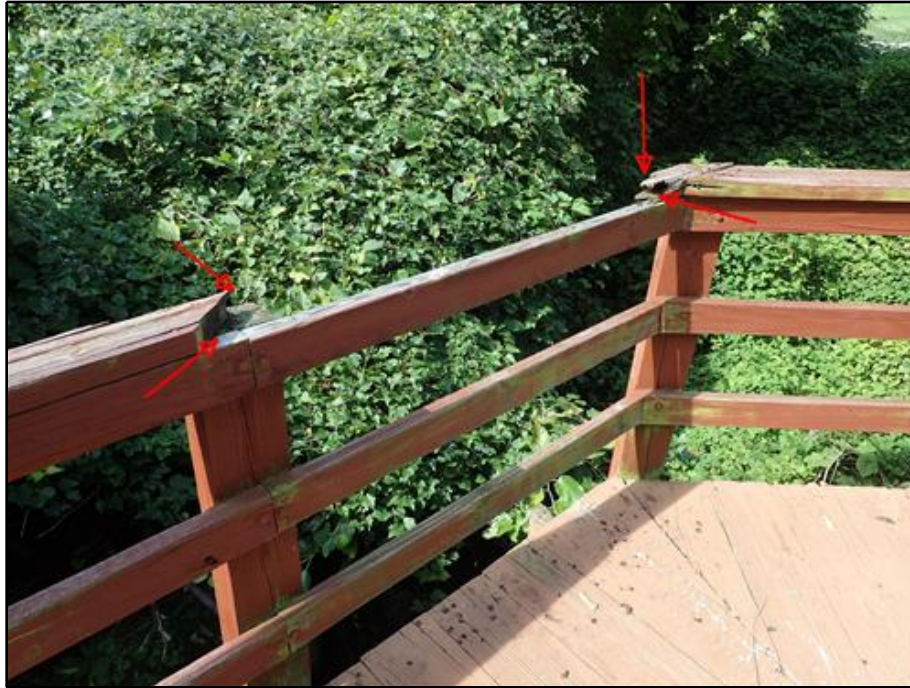
29. South Railing, Span 4 - 4 ft. Long Section of Top Cap Missing

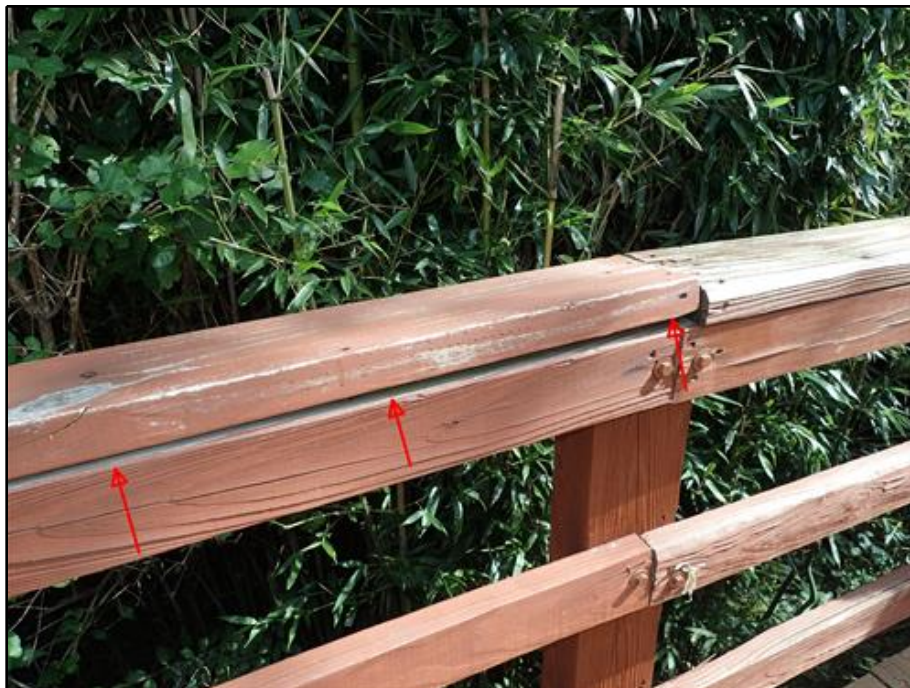
30. Span 7, North Railing - Top of Railing Cap Warped and Misaligned by 1 in.

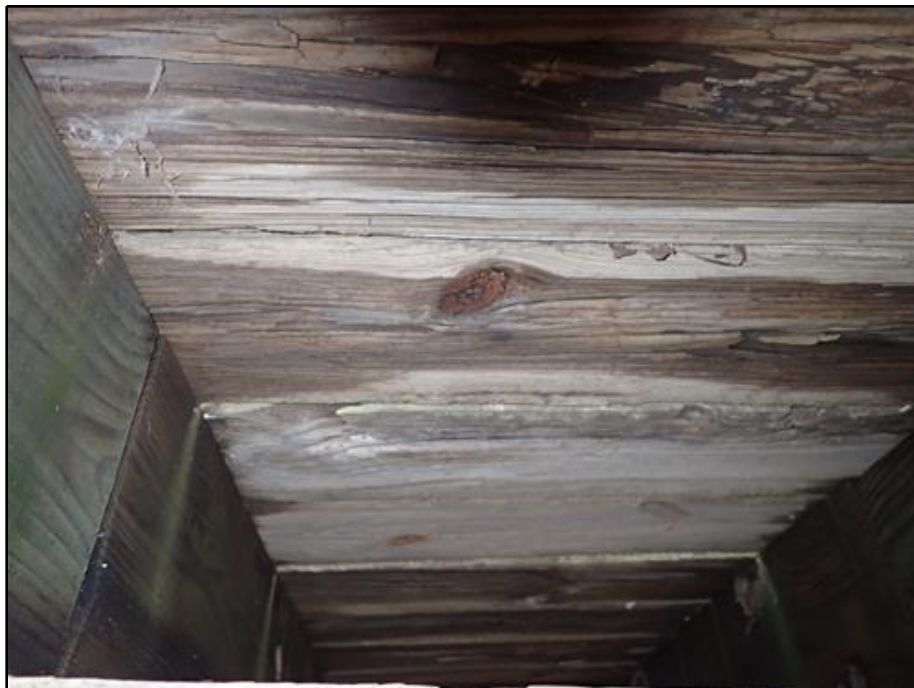
32. Underside Span 3 - Four Planks with Rot/Decay in a 3 ft. Width (Plank 1 is Worst)

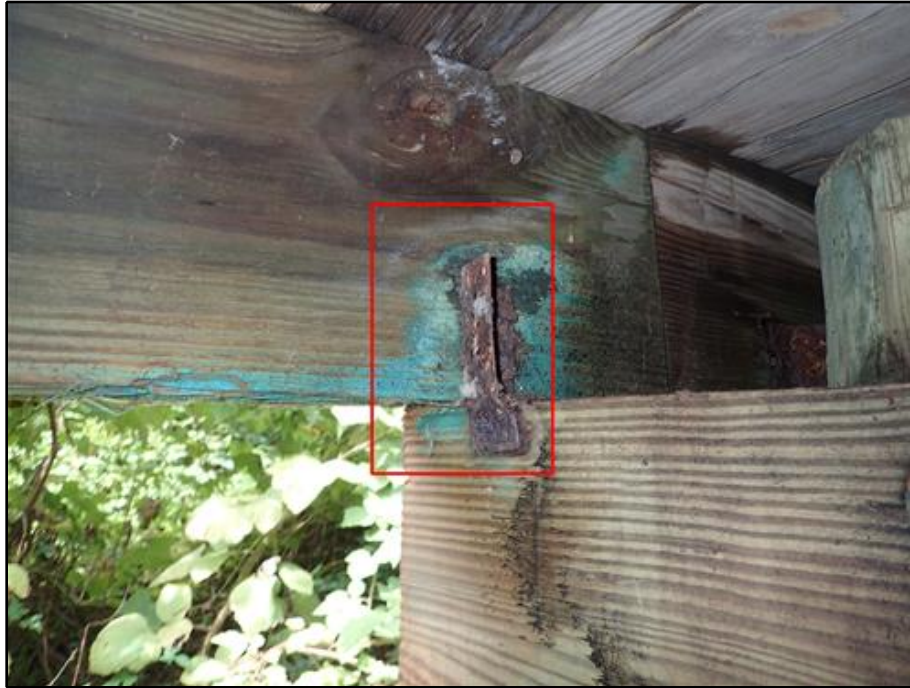
33. Heavy Corrosion on Stringer to Pile Cap Hardware

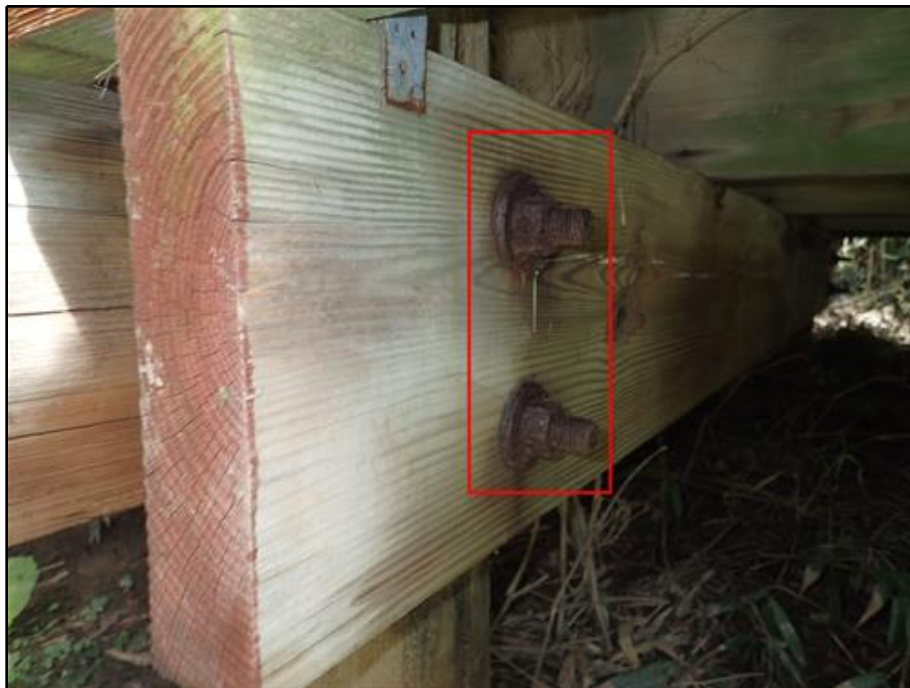
34. Typical Corrosion on Bent Cap Hardware

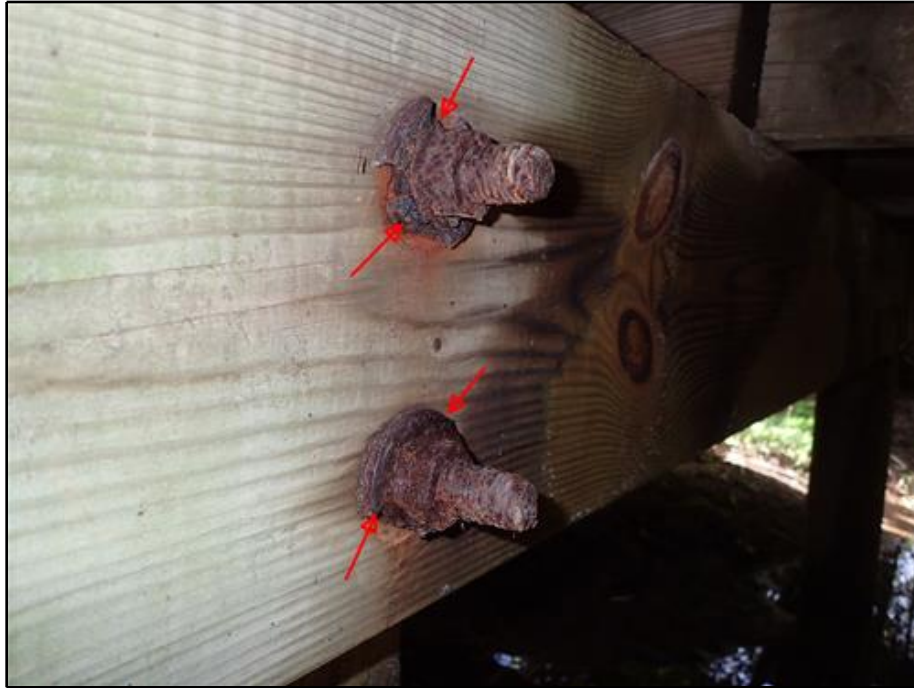
35. Heavily Corroded Washer at Bent Cap Hardware (Bent 7, South End Shown)

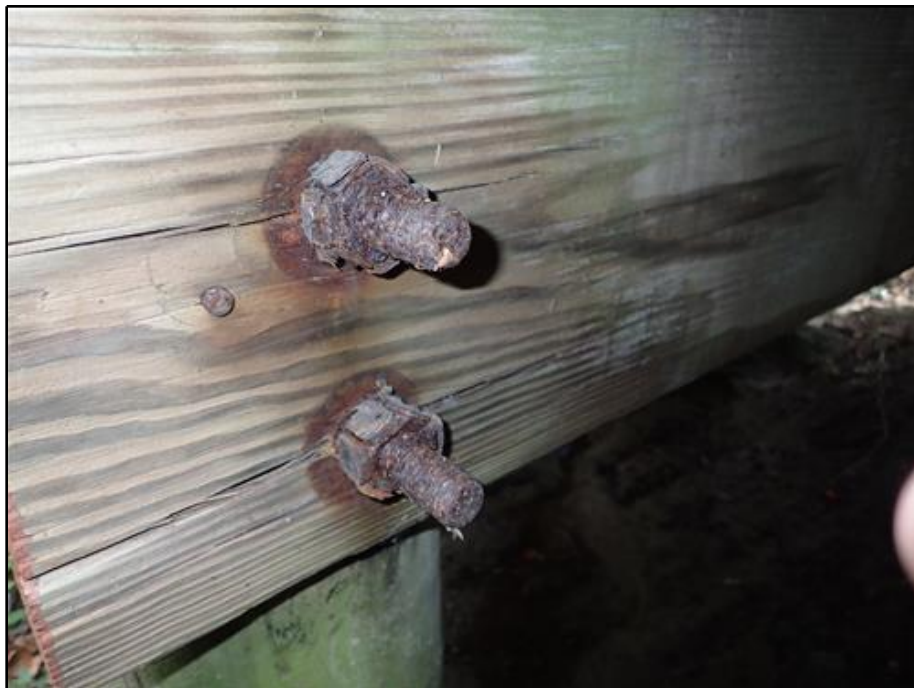
36. Heavier Corrosion on Pile Cap Hardware at Bent 5

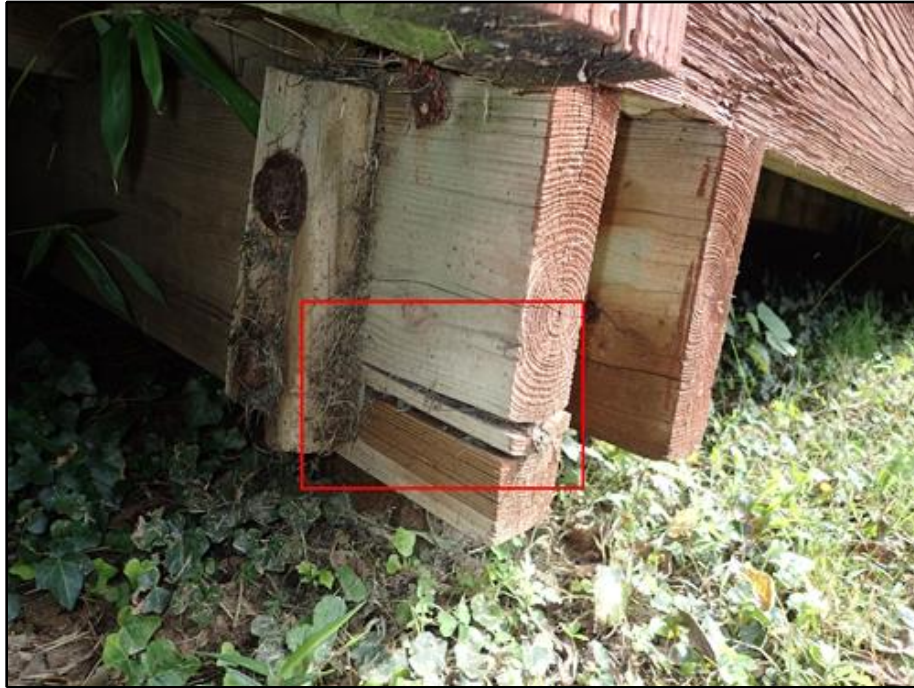
37. West Side Timber Pile Cap, 1 in. Open Check at South End at Pier 11

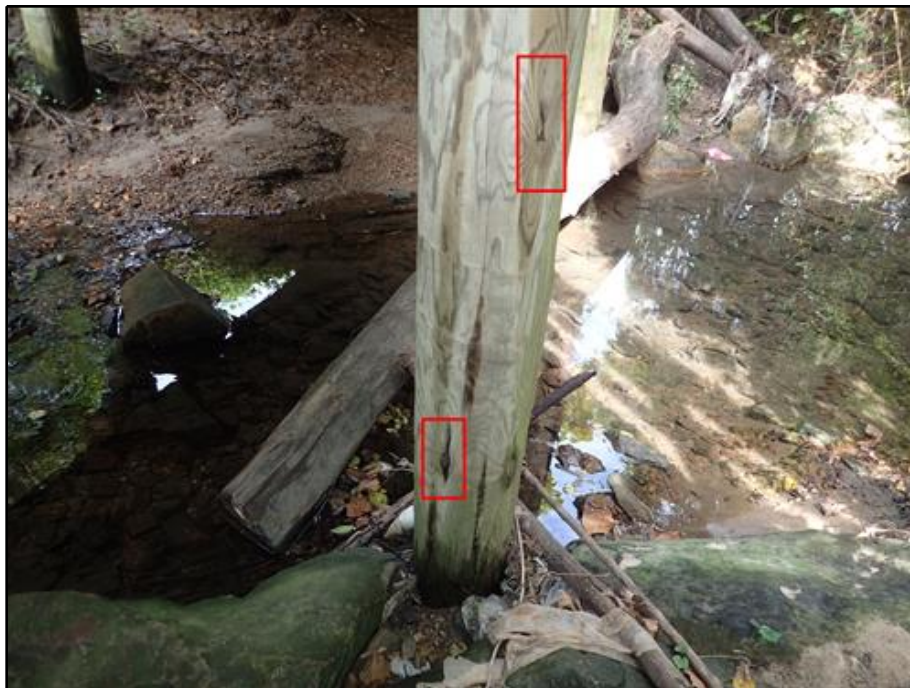
40. Bent 3, North Pile - Two (2) Areas of Decay with 1/2 in. Pick Penetrations up to 8 in. High

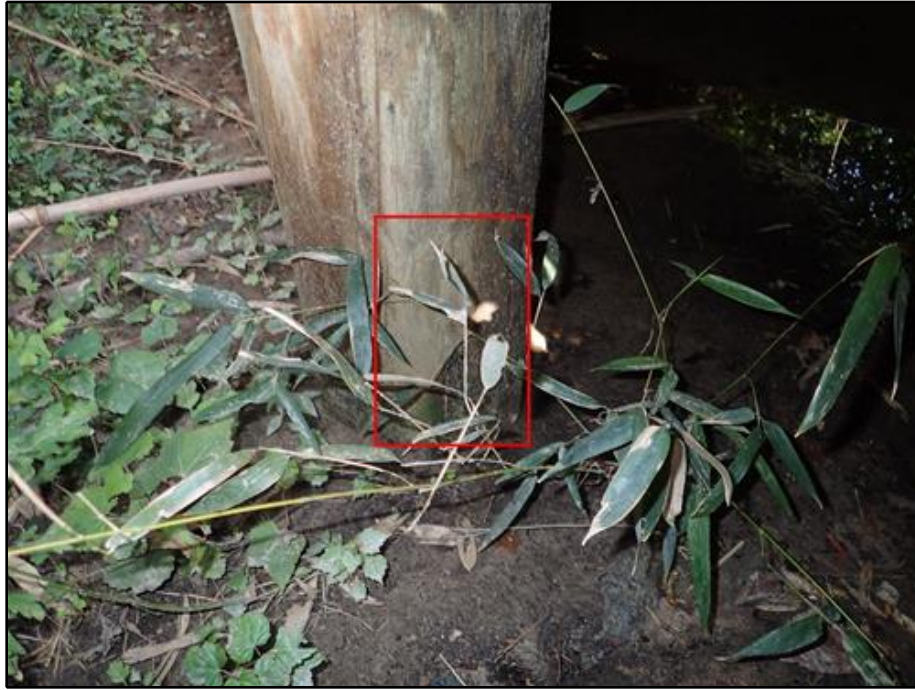
41. Bent 7, South Pile - 6 in. Decay on East Face

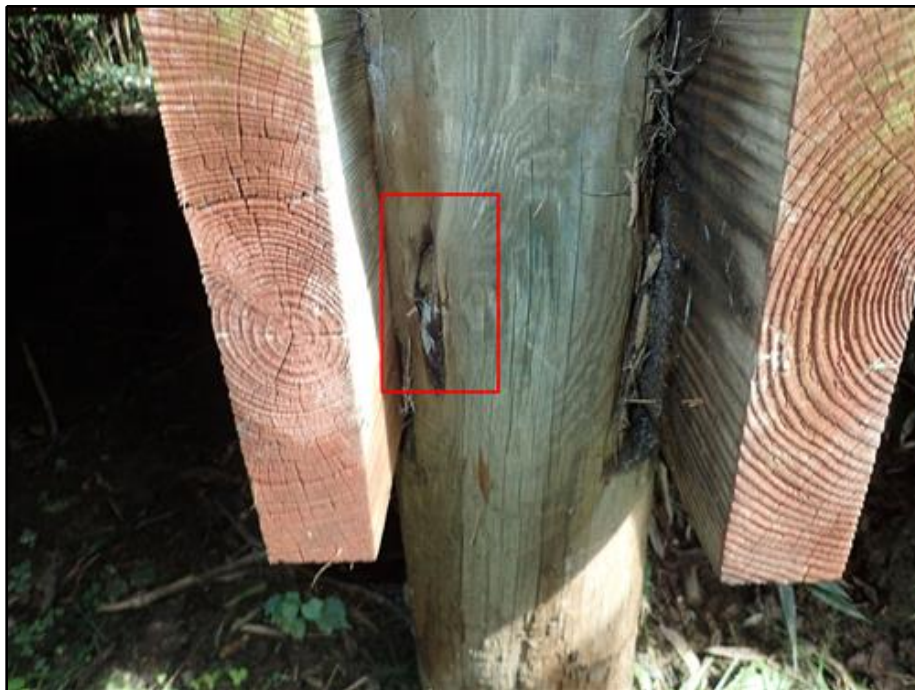
42. Bent 9, South Pile - Decay up to 1 ft. High x 3/4 in. Deep
