2018 BRIDGE INSPECTION REPORT
August 22, 2018

BRIDGE NO. PB-050
KING FARM PARK
OVER
TRIBUTARY TO WATTS BRANCH

EBA^{OD}
ENGINEERING

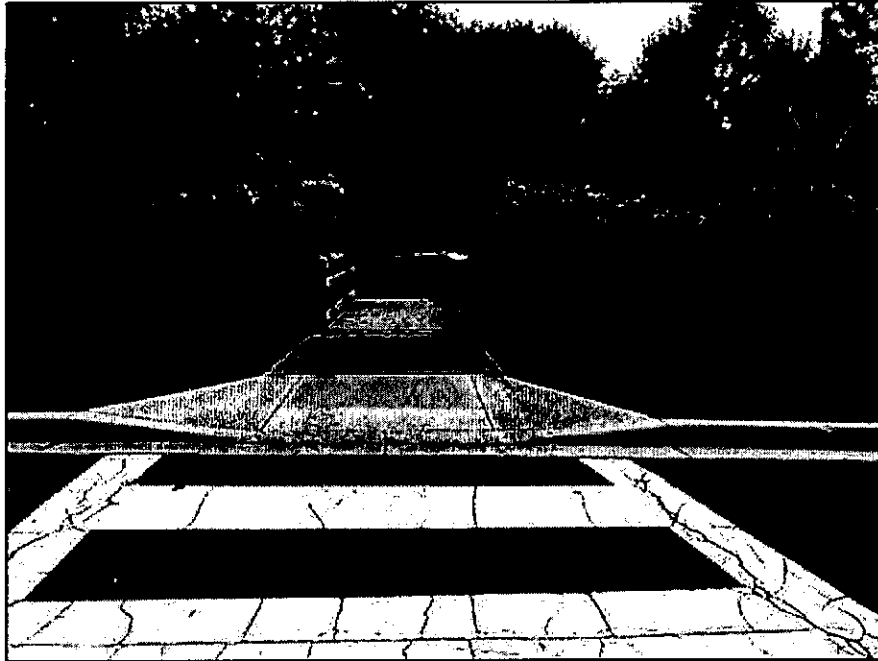
The approach concrete/brick walkways are in good condition (see Photographs 3 and 4). There are several minor cracks and spalls in both approach walkways. Typically, the minor spalls range from 3 square inches to up to 16 square inches with up to a 3/8" depth. At the North Approach Sidewalk, there is a 3'-10" long x 1/8" open crack (see Photograph 7). Since the last 2013 Bridge Inspection Report, the ADA pad at the North Approach was replaced. At the east and west side of the North Approach sidewalk, there are full-width cracks with minor spalls emanating (see Photographs 8 and 9). Both the North and South Approach transitions are settled up to 1 1/2" creating potential tripping hazards (see Photographs 10 and 11).

3. North Approach Looking South

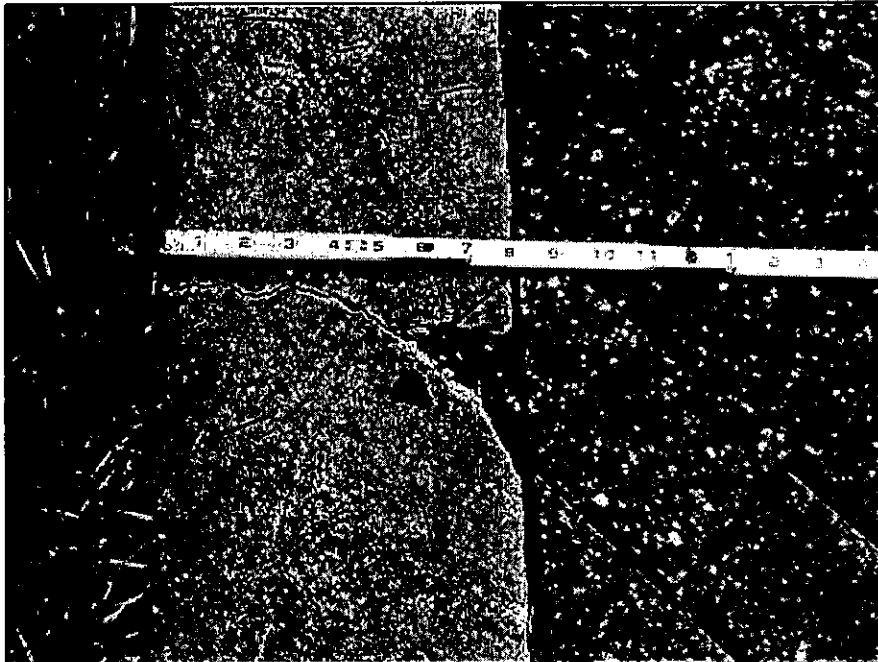
8. Hairline Cracking in the North Approach at the East Side

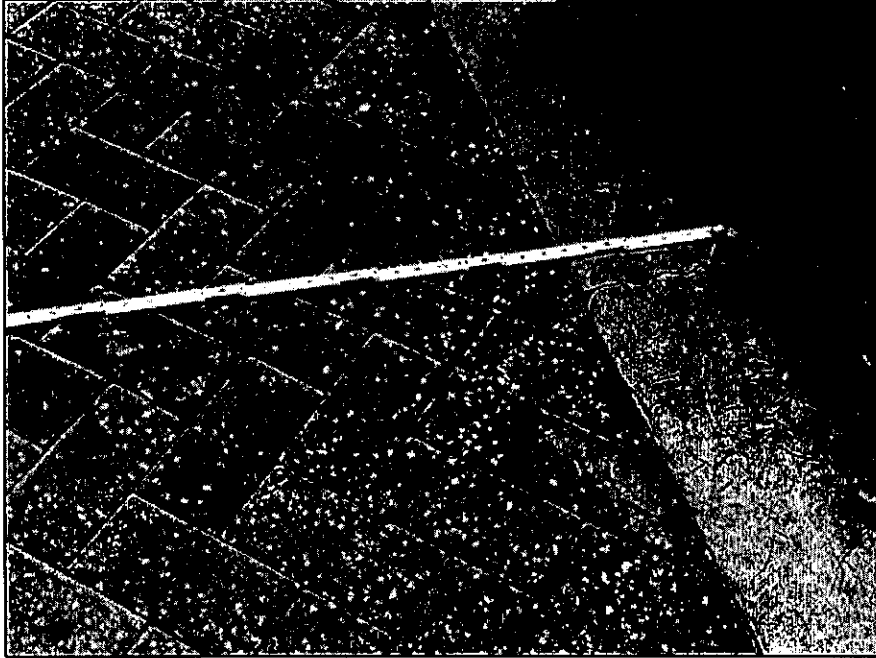
9. Hairline cracking in the North Approach at the West Side

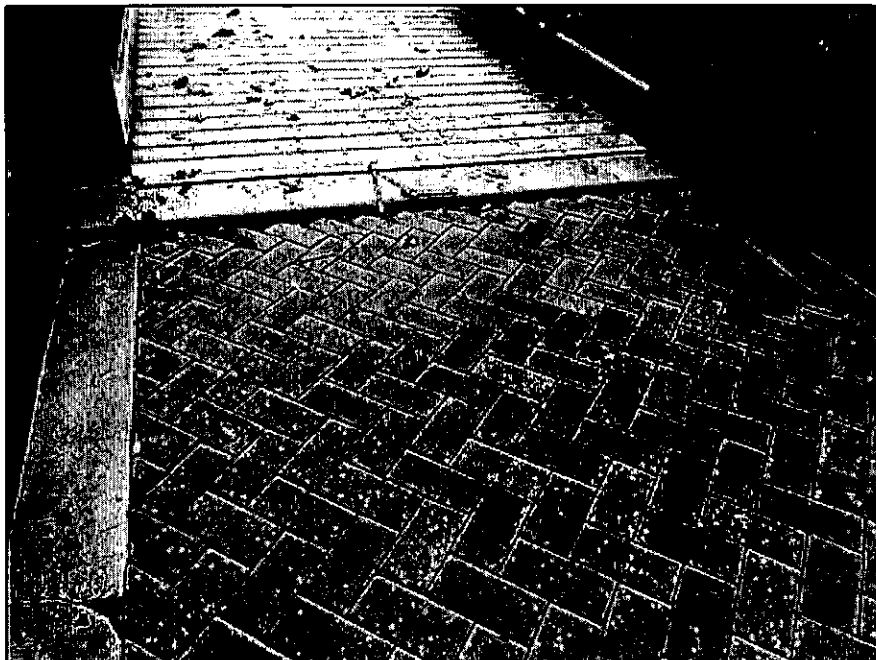
10. Up to 1 1/2" Settlement at the North Approach Concrete Backwall; Possible Trip Hazard

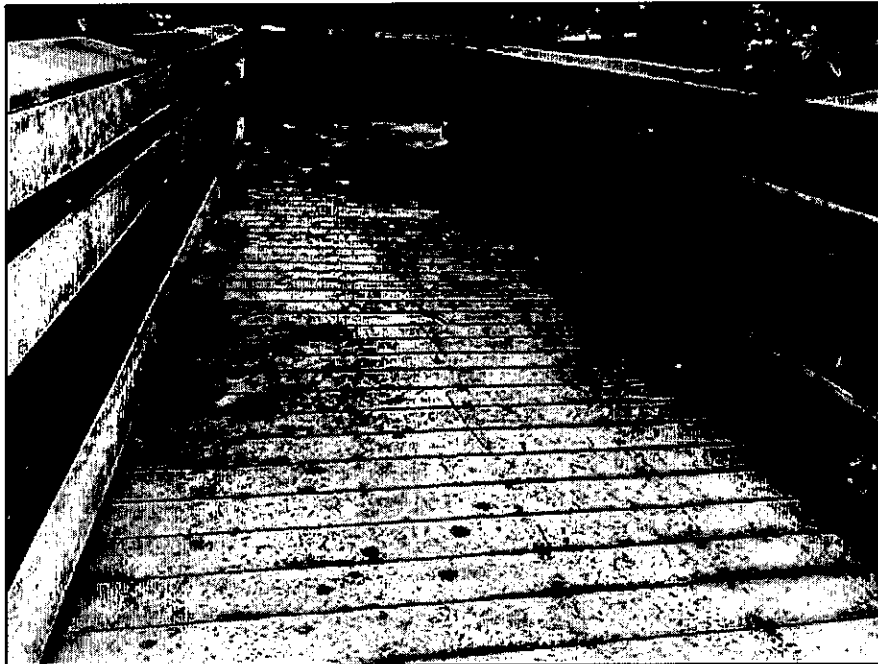
The composite lumber deck is typically in good condition. The timber deck and timber railing have been lined with composite materials and they are in good condition (see Photographs 12-15). Typically, there are gaps up to 1" open at the top corner of the railings (see Photograph 16). The timber railing posts exhibit typical checking and splintering at the south end of the east railing corner of the bridge. The 9th Post from the south end of the east railing exhibits up to a 1 1/2" open split approximately 14" long (see Photograph 17). There is a loose baluster at the east railing, 10th Post from the south end of the east railing (see Photograph 18). The base rail at the 7th post from north end of the east railing is broken and missing a 1'-8" long section (see Photograph 19). Both railings are crooked. Ice pick penetration in the timber railings is up to 3/4"±. There is minor algae growth throughout the structure. There is minor debris on the topside of the structure, especially at the south end. The underside of the deck is in good condition (see Photograph 20).

12. Main Span View of Deck Looking South

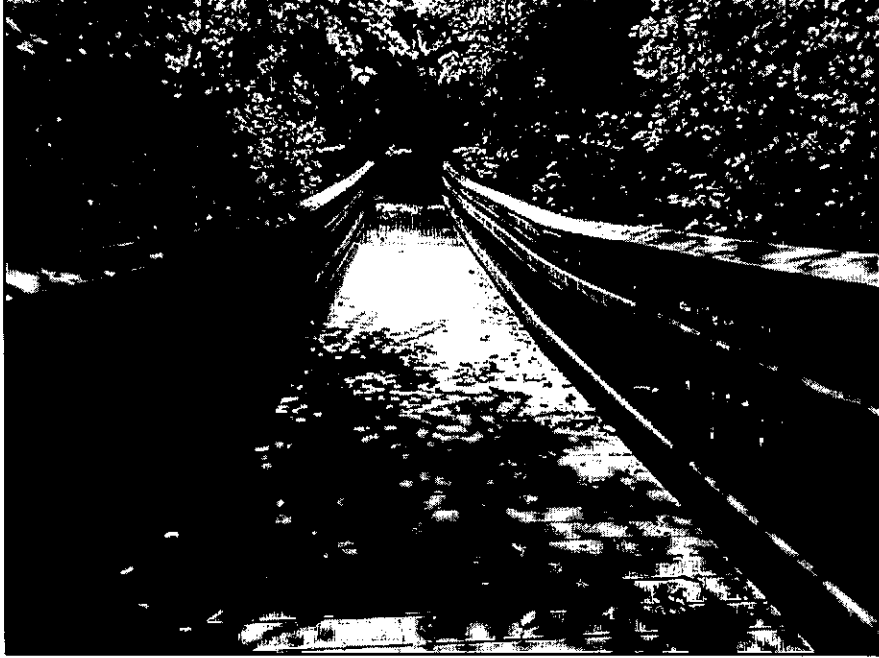
13. General Deck View Looking North

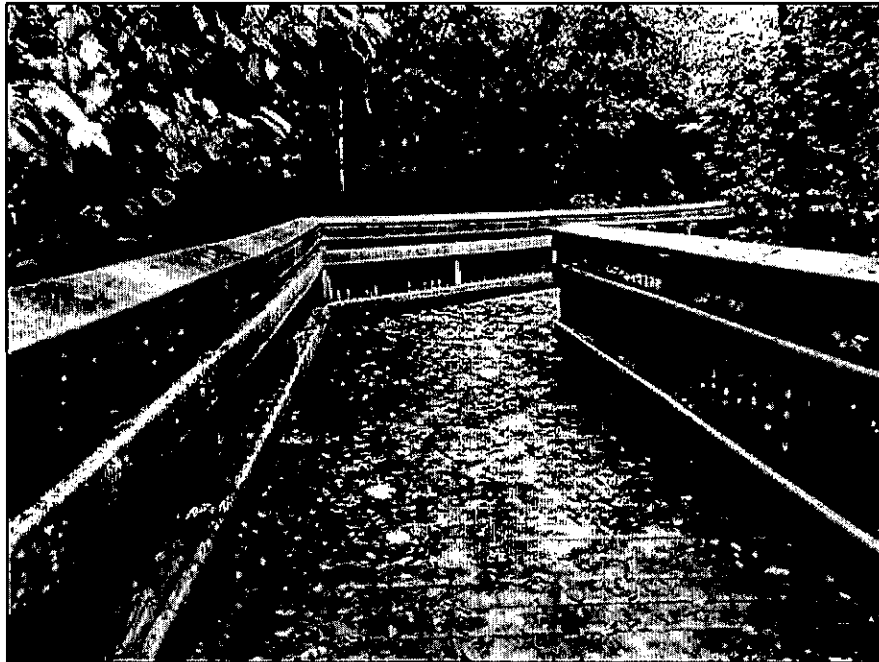
14. General View of Deck at the South end

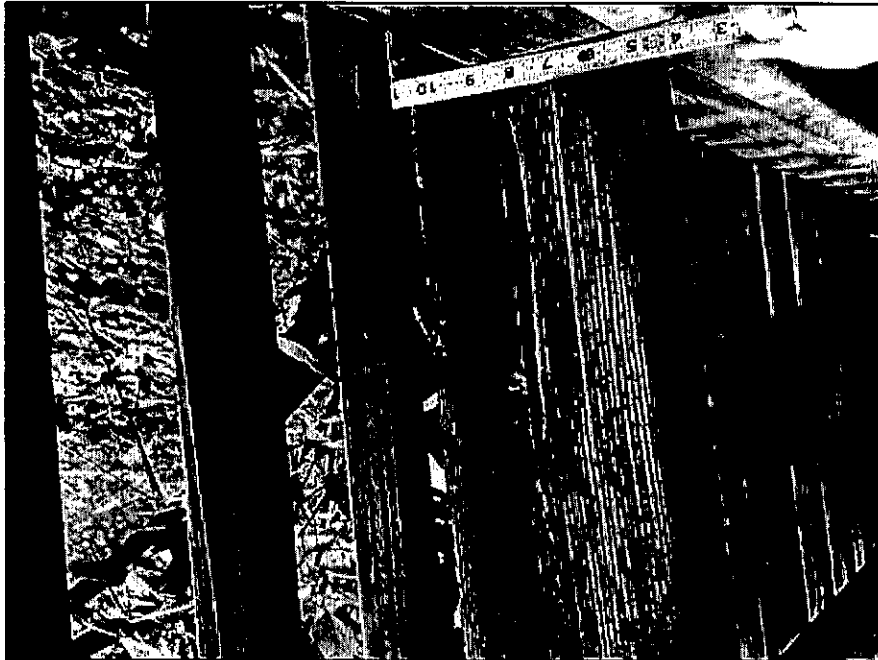
17. Up to 1 1/2" Open Split in 9th Wood Post from the South End of the East Railing

58.8 Typically, there are gaps up to 1" open at the top corner of the railings. The timber railing posts exhibit typical checking and splintering at the south end of the east railing corner of the bridge. The 9th Post from the south end of the east railing exhibits up to a 1 1/2" open split approximately 14" long. There is a loose baluster at the east railing, 10th Post from the south end of the east railing. The base rail at the 7th post from north end of the east railing is broken and missing a 1'-8" long section. Both railings are crooked. Ice pick penetration in the timber railings is up to 3/4"±.

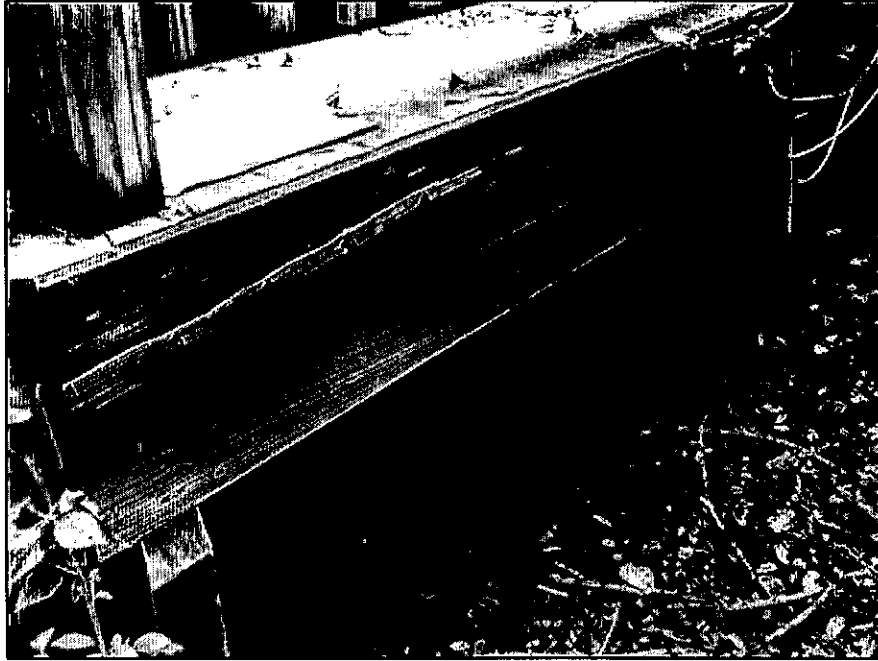
The timber beams are in good condition (see Photograph 20). There is a 3'-0" long x 1/4" open splinter in the fascia board at the west side of span 14 (see Photograph 21). Typically, the 7" high x 3/4" thick and 6" high x 2" thick fascia boards, there are up to 1/4" pick penetration. At the east side of Span 15, there is an approximately 4" diameter tree growing from the underside (see Photograph 22). At the west side of Span 12, the fascia board is misaligned approximately 3/16" out. Both timber fasciae exhibit typical checking, deterioration, and splitting.

21. 3'-0" Long x 1/4" Open Splintering in Fascia Board at the West Side of Span 14

The timber beams are in good condition. There is a 3'-0" long x 1/4" open splinter in the fascia board at the west side of span 14. Typically, the 7" high x 3/4" thick and 6" high x 2" thick fascia boards, there are up to 1/4" pick penetration. At the east side of Span 15, there is an approximately 4" diameter tree growing from the underside. At the west side of Span 12, the fascia board is misaligned approximately 3/16" out. Both timber fasciae exhibit typical checking, deterioration, and splitting.

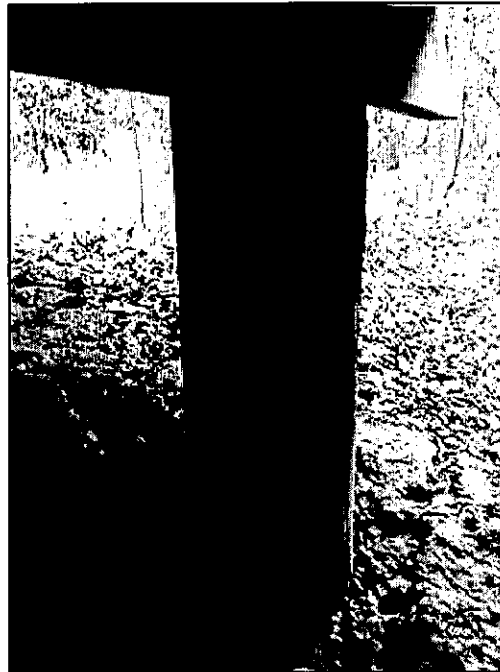
The timber piles, pile caps, and diaphragms are in good condition. Typically, there is checking of the timber piles, pile caps, and diaphragms (see Photographs 26 and 27). There are two rot sections approximately 3" high x 2" wide x up to 3/4" of pick penetration in the west Pile at Bent 10 (see Photographs 28 and 29). Also, there is a 10' long section of erosion around this pier between spans 9 and 10 (see Photograph 30).

28. Approximately 3" High x 2" Wide x Up to 3/4" Pick Penetration Rot in west Pile at Bent 10

60.2 The timber piles, pile caps, and diaphragms are in good condition. Typically, there is checking of the timber piles, pile caps, and diaphragms. There are two rot sections approximately 3" high x 2" wide x up to 3/4" of pick penetration in the west Pile at Bent 10. Also, there is a 10' long section of erosion around this pier between spans 9 and 10.
