2018 BRIDGE INSPECTION REPORT

BRIDGE NO. PB-065

DAWSON FARM PARK PEDESTRIAN BRIDGE

TRIBUTARY TO CABIN JOHN CREEK

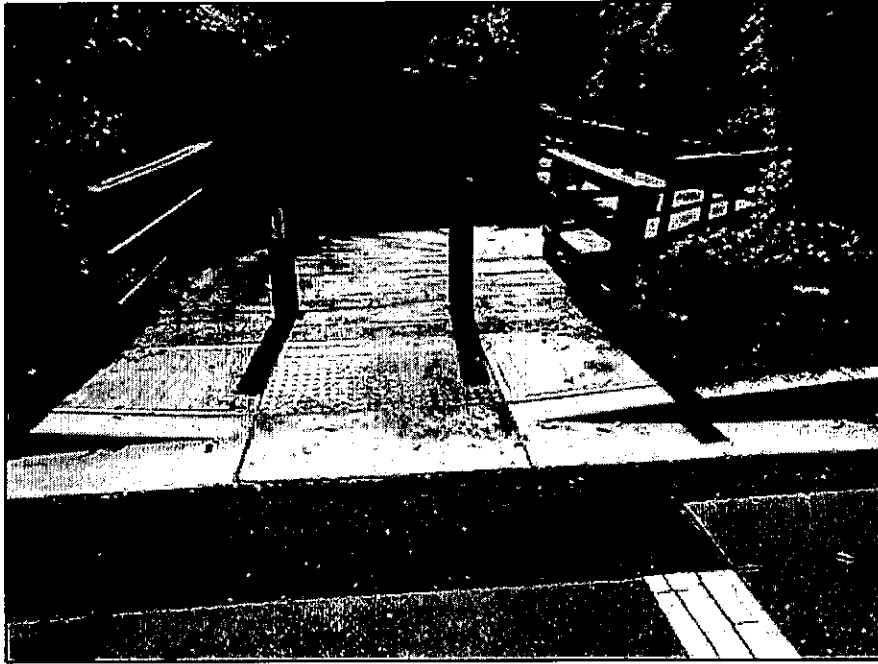
3. West Approach Looking East

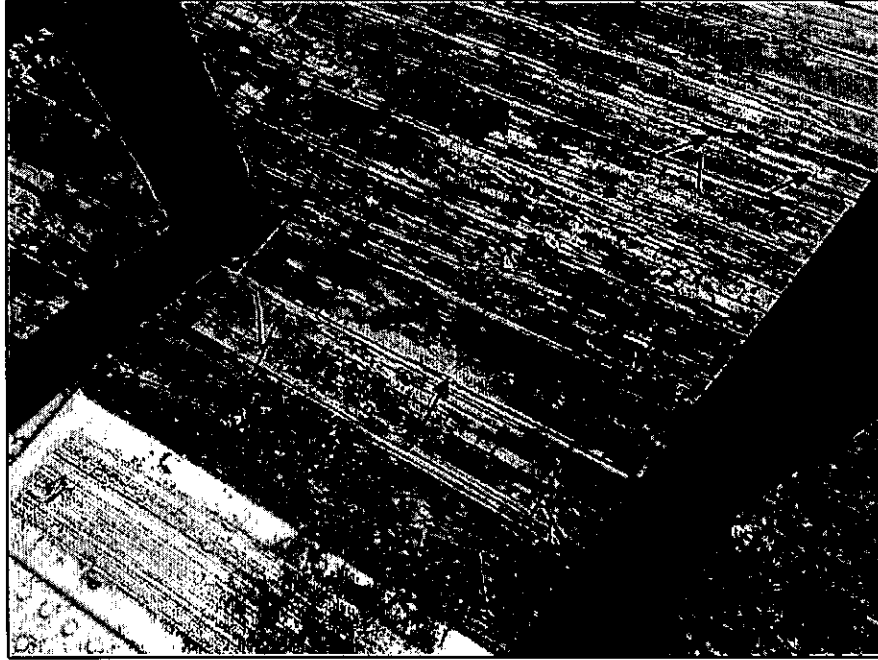
9. Span 1 - 3'-11" Long Loose Board Between Posts Near West Approach

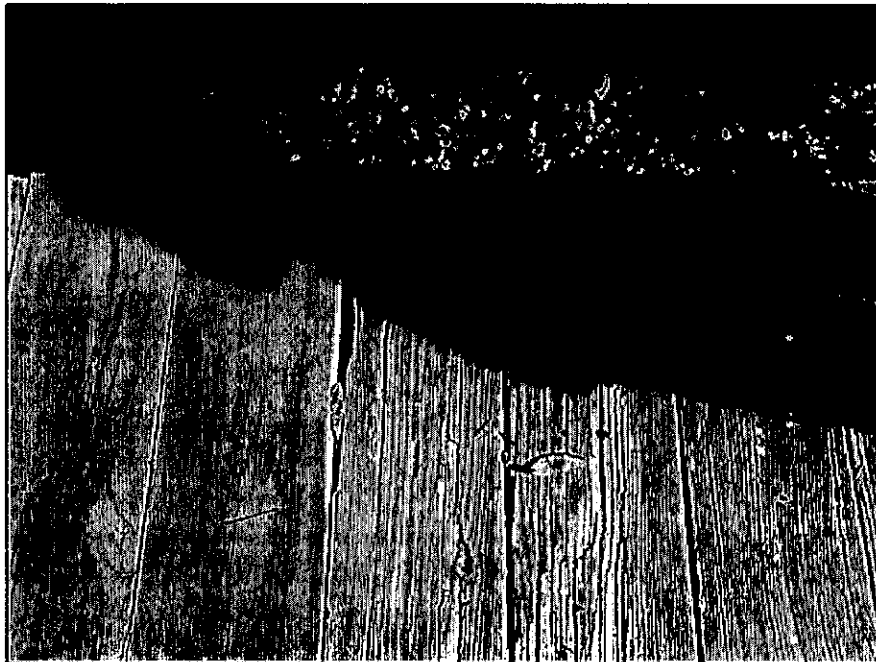
14. Span 5, Plank 2 - 1 ft. 4 in. Wide x 4 in. Long Area of Rot/Decay with 3/4 in.
Pick Penetrations

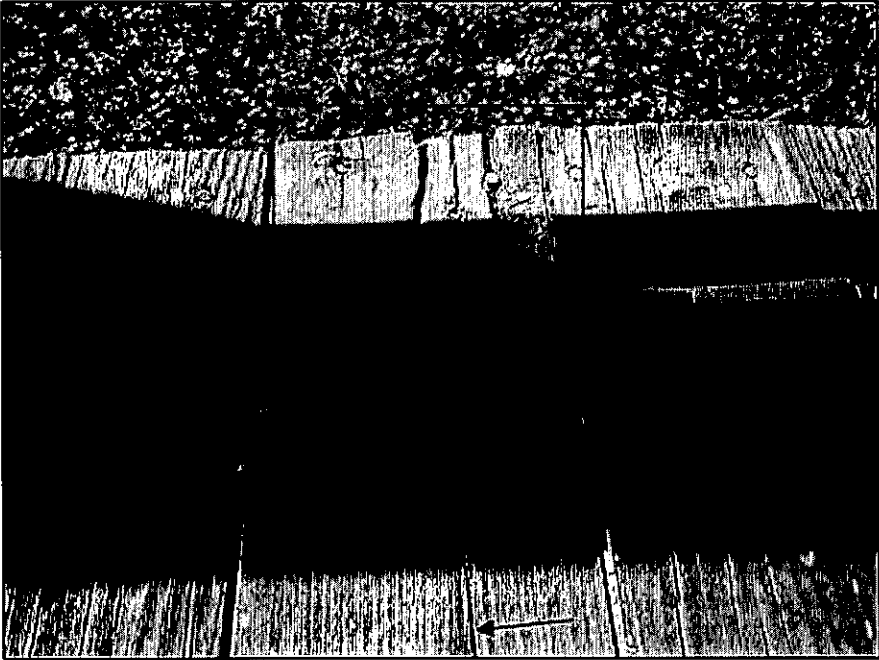
17. Span 12, Plank 3, South End - 3" Wide Area of Edge Splintering

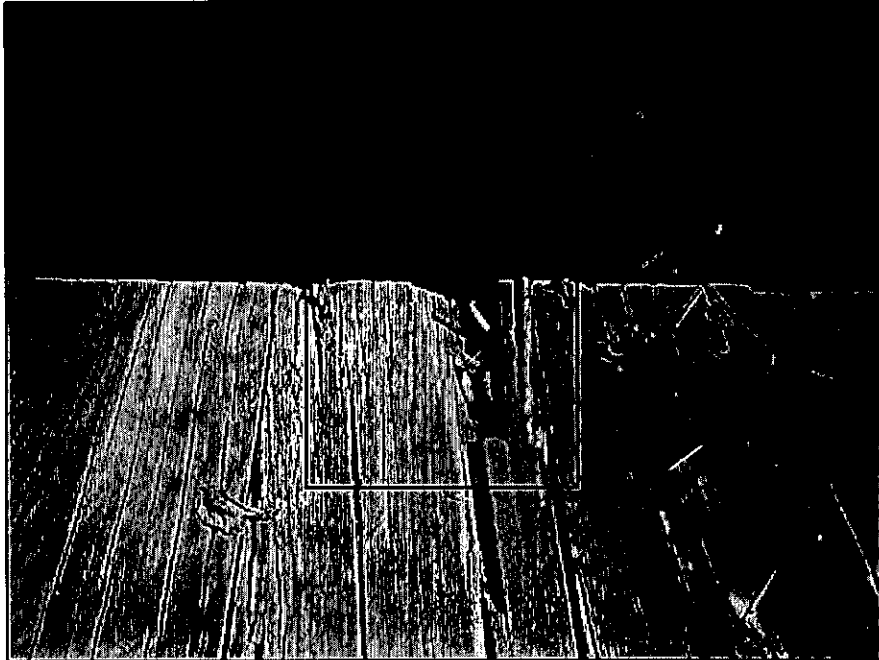
18. Span 12, Plank 5 - Exposed and Raised Nail with Adjacent Splintering

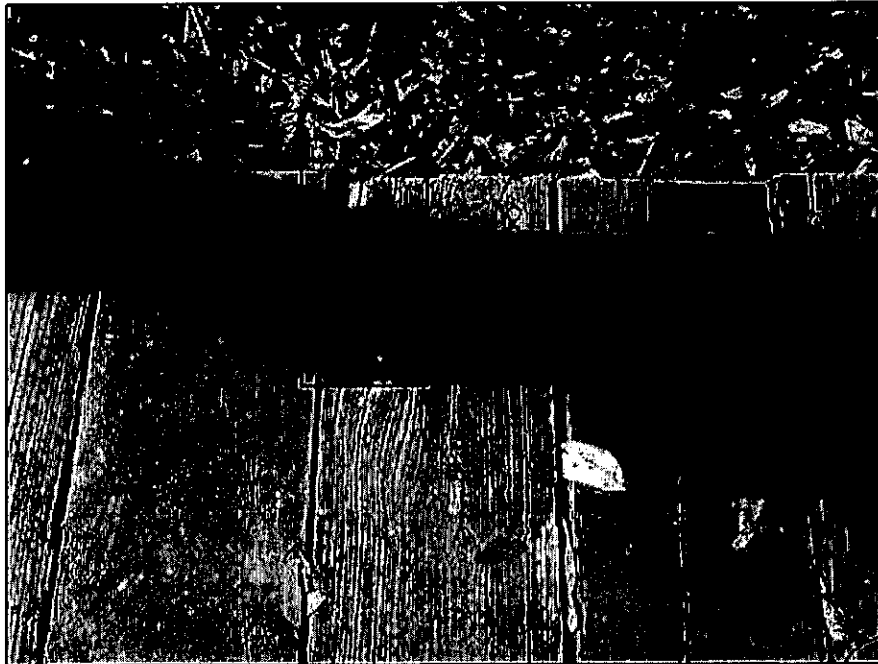
20. Span 14, Plank 13, South End - 3 in. Edge Splintering

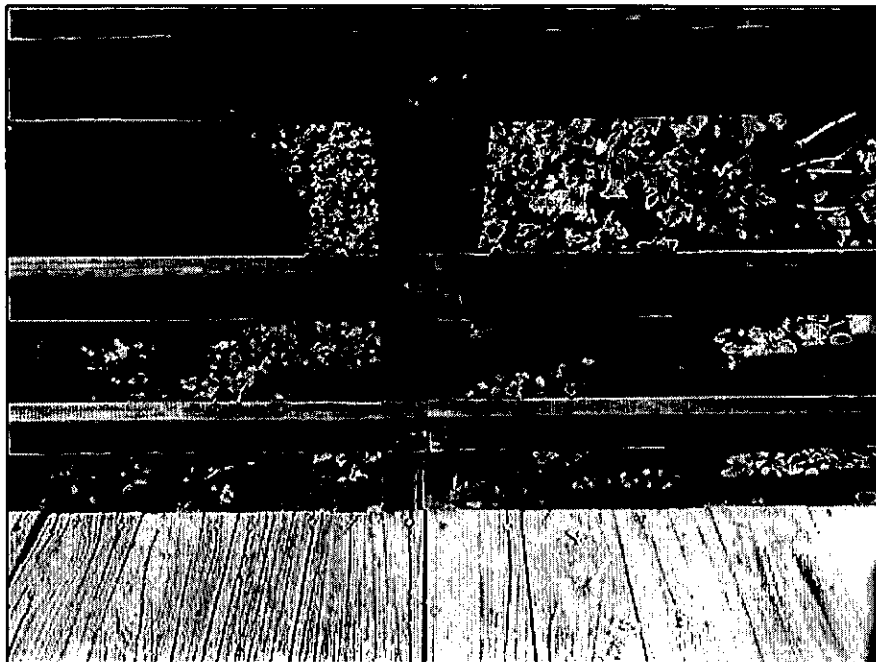
The timber railings on each side of the bridge are generally in satisfactory condition but are not plumb with the deck. Typically, the railings and posts exhibit checks, and vertical splits running full height (see Photograph 22). There are missing washers and splitting of the bridge railing Post 1, Span 9 at the south railing (see Photograph 23). Post 1 is loose and the bolts have slightly corroded. At the post, there are typical splintering at the fascia of the stringers and typical open checks at the post connections (see Photograph 25). At the north railing of Span 1, there is splintering at the bottom rail (see Photograph 26). There are multiple rails that are also bent and warped (see Photograph 24). There is a name plaque on the south bridge railing (see Photograph 27). There is typically, up to 1/8" open checks in the top cap of railing (see Photograph 28). At the South Railing in Span 4, there is a 4'-0" long section of the top cap missing (see Photograph 29). The remaining portion of the missing top cap exhibits a significant section of rot/decay. There is a misaligned bridge railing at the north railing of Span 7 of the bridge (see Photograph 30). The warped/misaligned top cap is up to 1" misaligned.

22. Typical Split at Post Connection - Span 3, Post 2

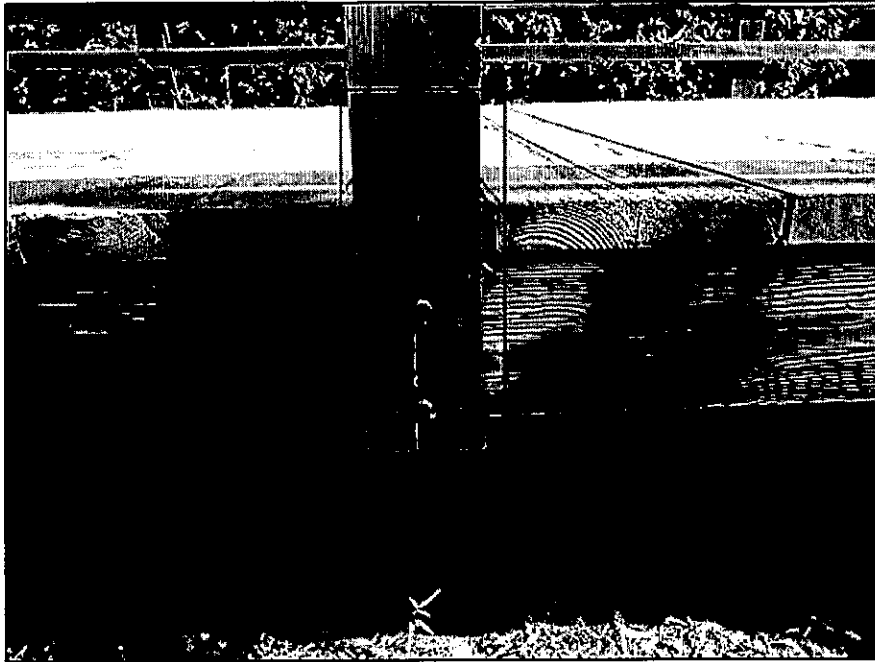
23. Typical Split in Railing (Span 9, Post 1, South Railing Shown)

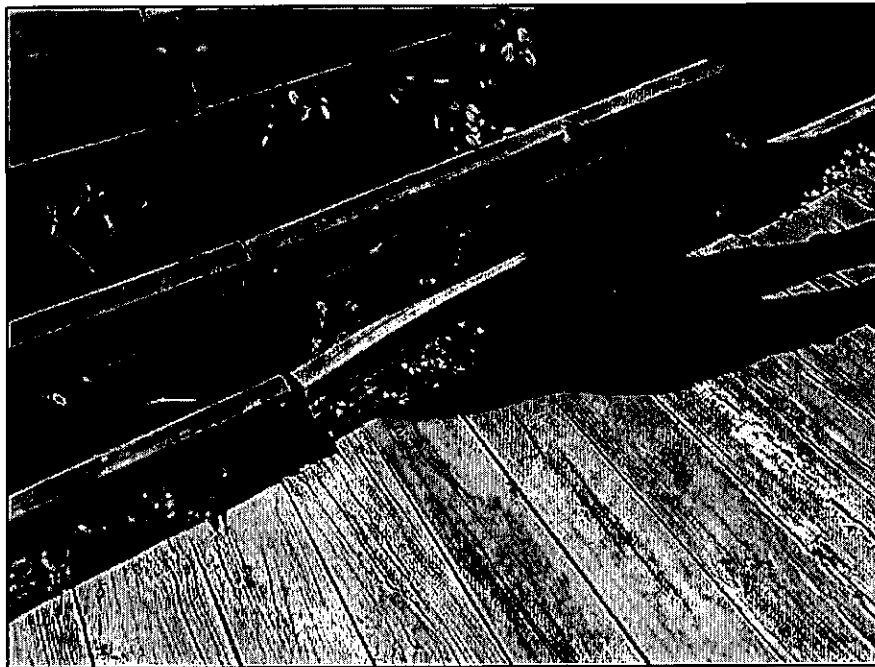
24. Span 5 - Warped Lower Rail Member of North Railing; Vertical Check in Rail Post

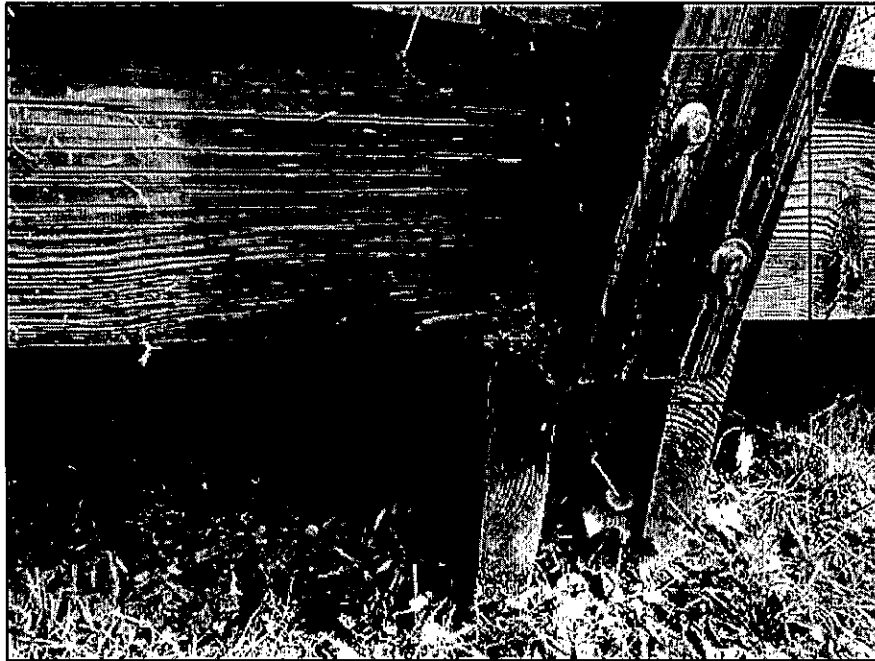
25. Typical Splintering at Fascia Stringer (Pier 12, South Side Shown) and Typical Open Checks at Hardware Connections

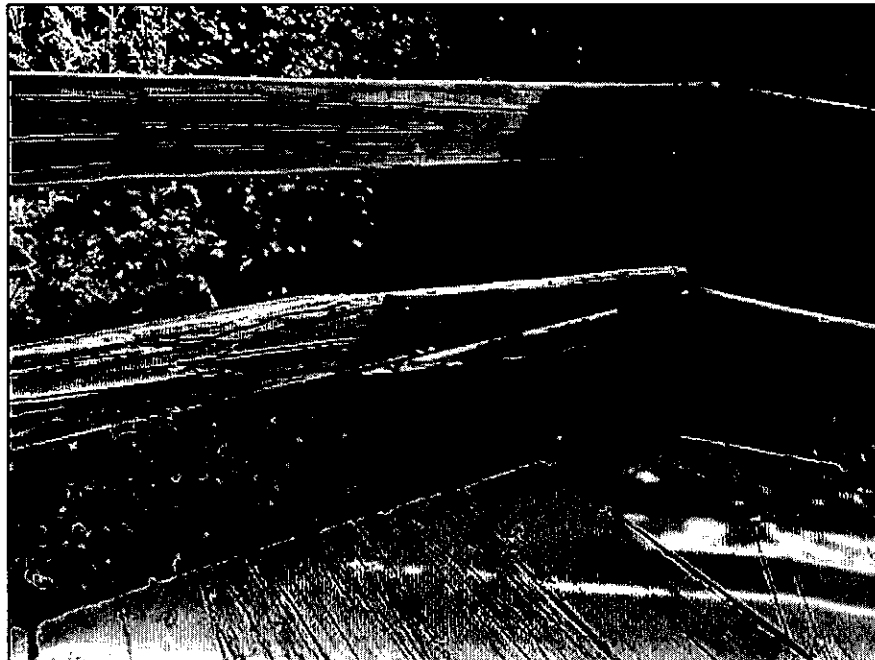
26. Span 1, North Railing - Splintered Section of Bottom Rail

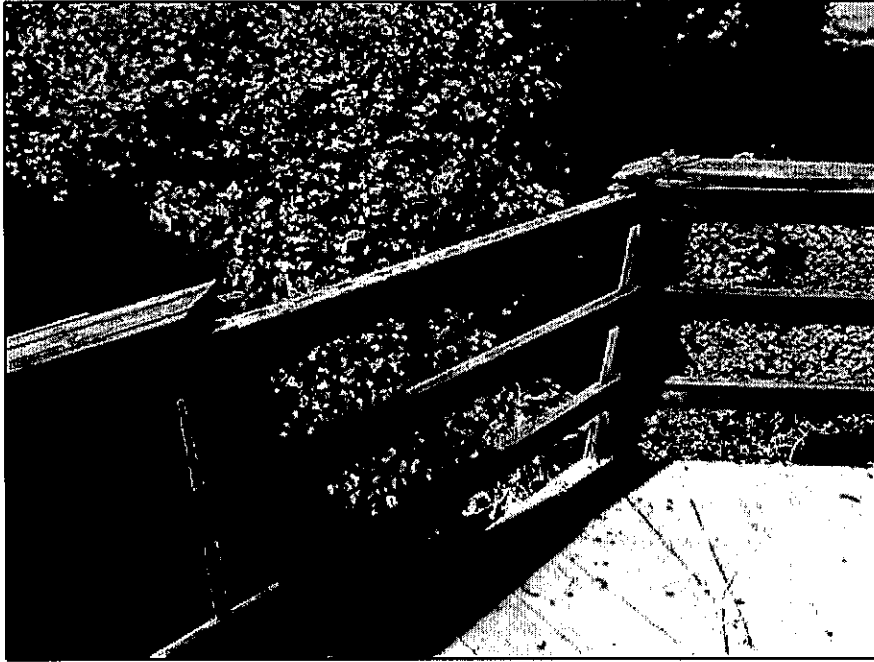
29. South Railing, Span 4 - 4 ft. Long Section of Top Cap Missing

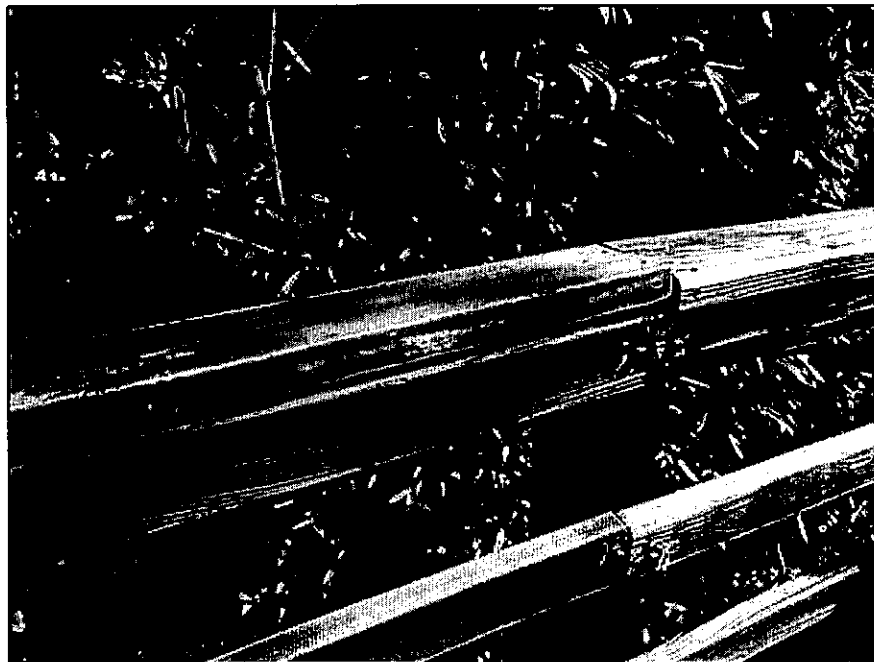
30. Span 7, North Railing - Top of Railing Cap Warped and Misaligned by 1 in.

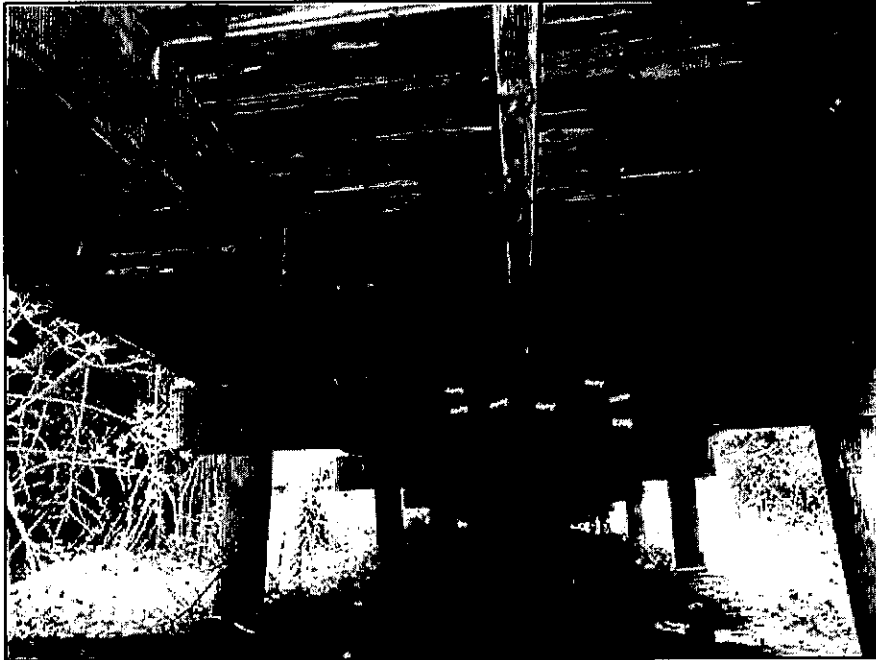
The underside of the deck exhibits minor decay and deterioration. The most severely deteriorated planks are in Span 3 (see Photographs 31 and 32).

The timber beams are in satisfactory condition overall (see Photograph 31). Typically, the timber beams and diaphragms exhibit horizontal splits, checks, and shakes. The fasciae exhibit typical checking. There is typical heavy corrosion of the connection plates between the beams and pile caps (see Photograph 33). At some locations, the connection plates are missing.

31. Typical Underside

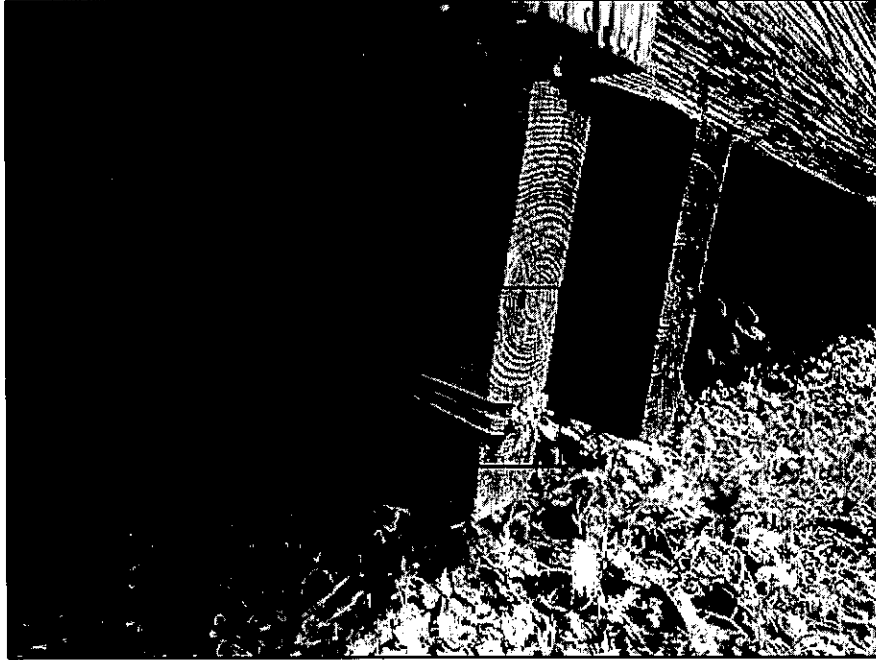
37. West Side Timber Pile Cap, 1 in. Open Check at South End at Pier 11

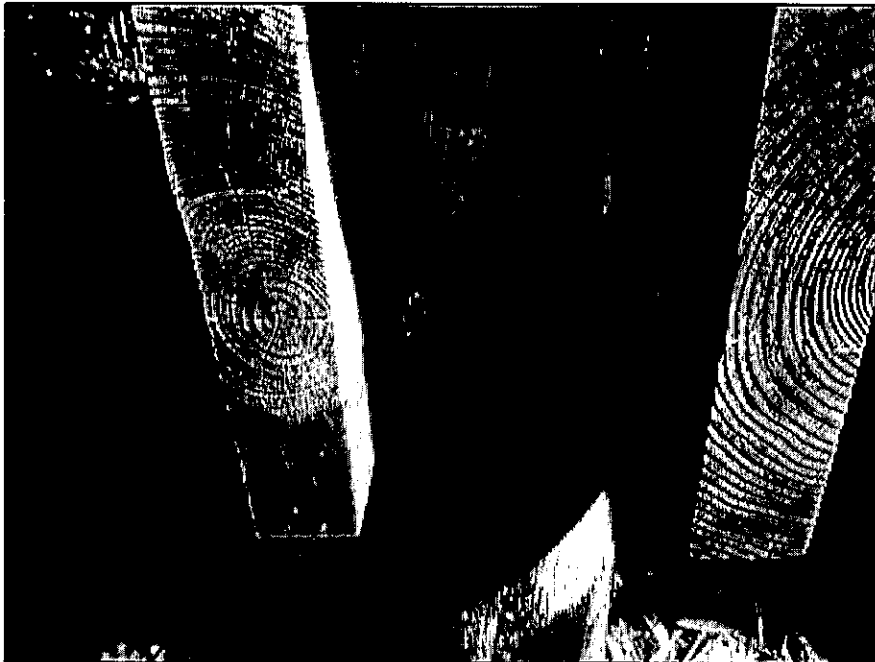
42. Bent 9, South Pile - Decay up to 1 ft. High x 3/4 in. Deep
