2018 BRIDGE INSPECTION REPORT  
August 22, 2018

**BRIDGE NO. PB-050**  
**KING FARM PARK**  
**OVER**  
**TRIBUTARY TO WATTS BRANCH**

**2018 BRIDGE INSPECTION REPORT**  
**BRIDGE NO. PB-050**

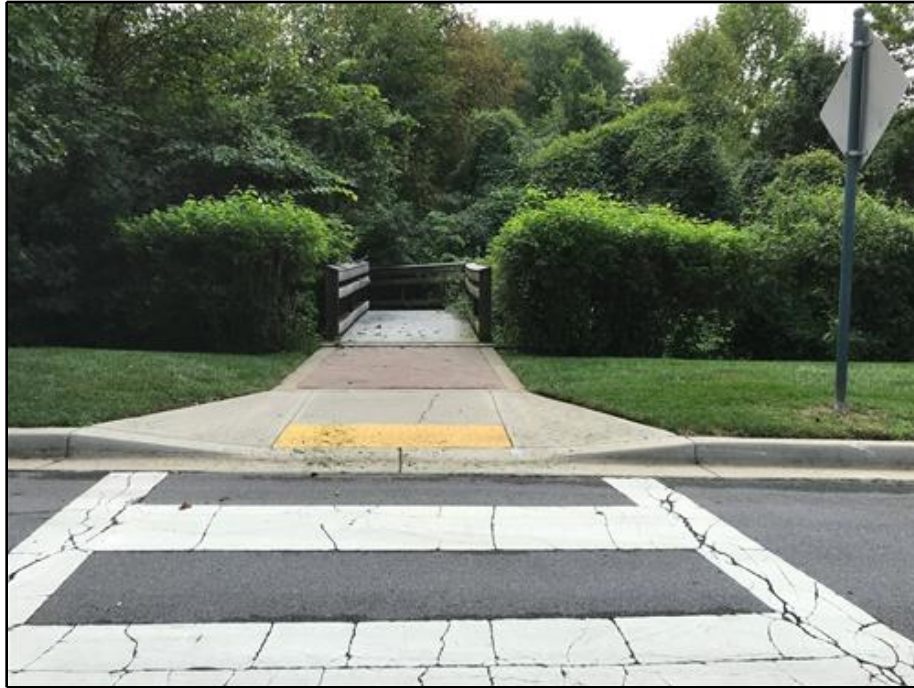
The approach concrete/brick walkways are in good condition (see Photographs 3 and 4). There are several minor cracks and spalls in both approach walkways. Typically, the minor spalls range from 3 square inches to up to 16 square inches with up to a 3/8" depth. At the North Approach Sidewalk, there is a 3'-10" long x 1/8" open crack (see Photograph 7). Since the last 2013 Bridge Inspection Report, the ADA pad at the North Approach was replaced. At the east and west side of the North Approach sidewalk, there are full-width cracks with minor spalls emanating (see Photographs 8 and 9). Both the North and South Approach transitions are settled up to 1 1/2" creating potential tripping hazards (see Photographs 10 and 11).

3. North Approach Looking South

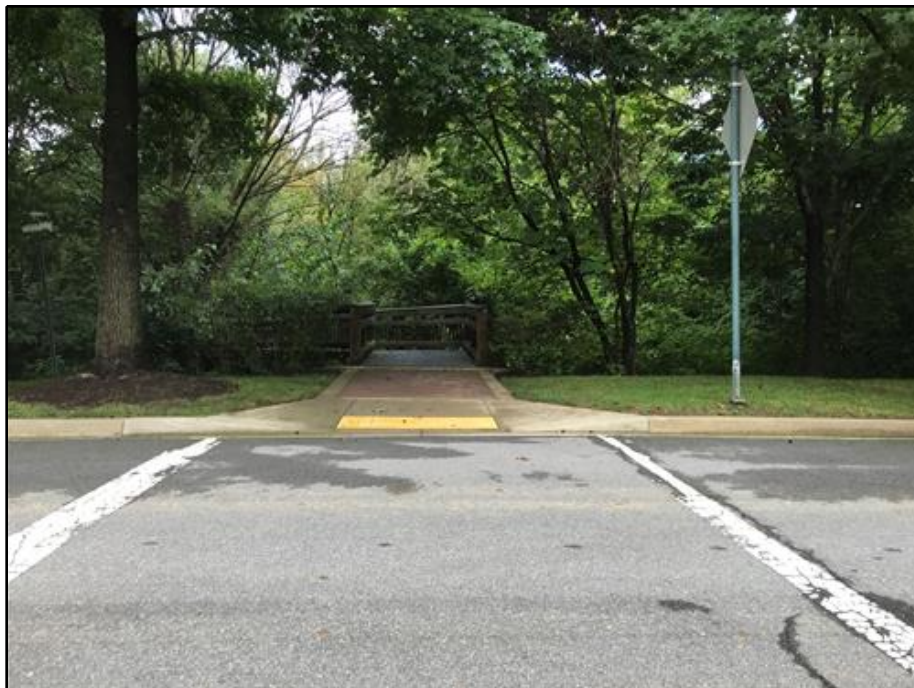
4. South Approach Looking North

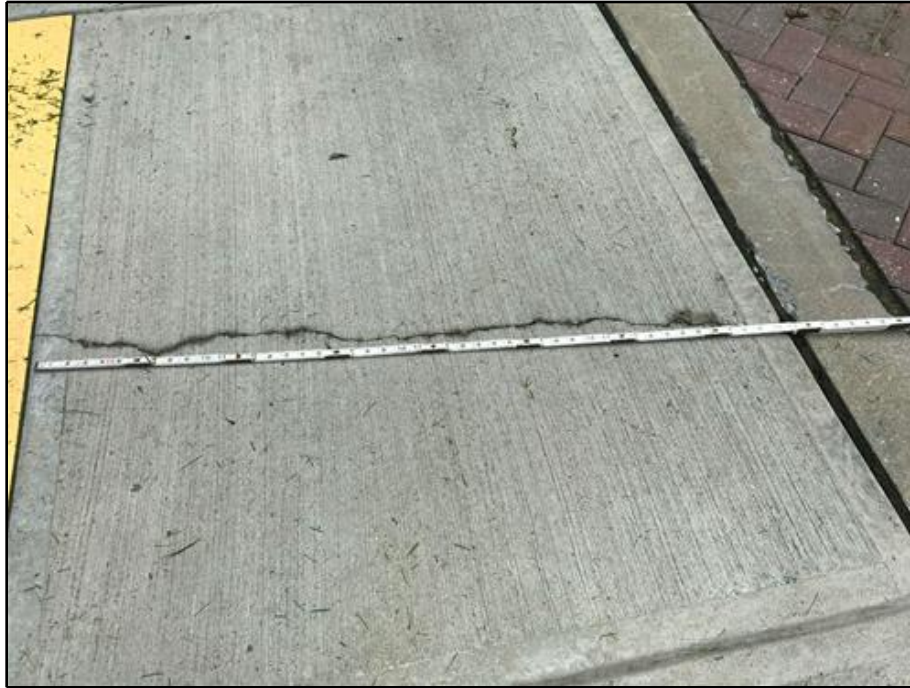
7. Approximately 3'-10" Long x 1/8" Open Crack in Concrete Sidewalk

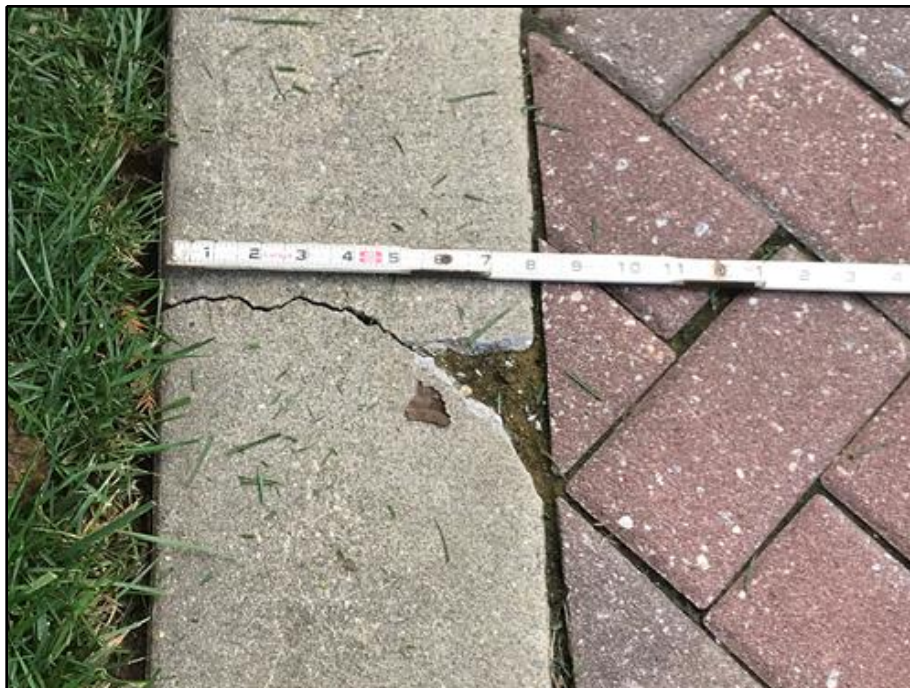
8. Hairline Cracking in the North Approach at the East Side

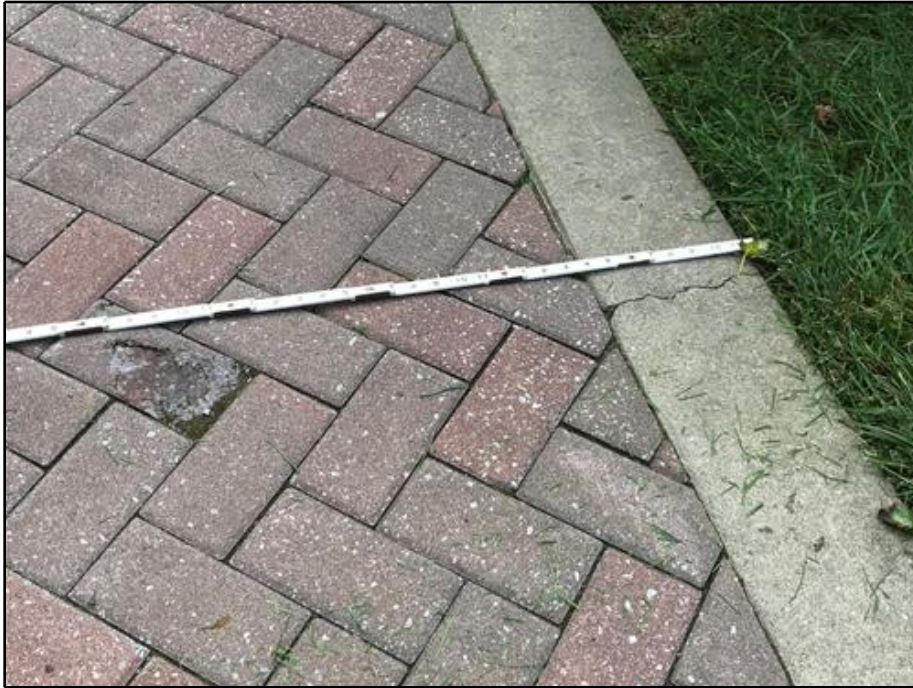
9. Hairline cracking in the North Approach at the West Side

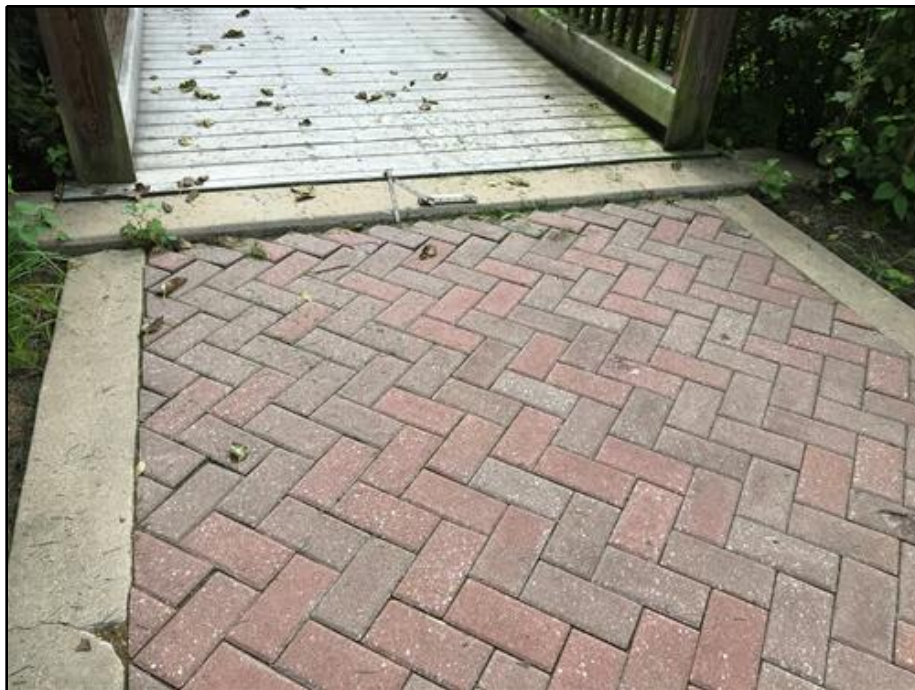
10. Up to 1 1/2" Settlement at the North Approach Concrete Backwall; Possible Trip Hazard

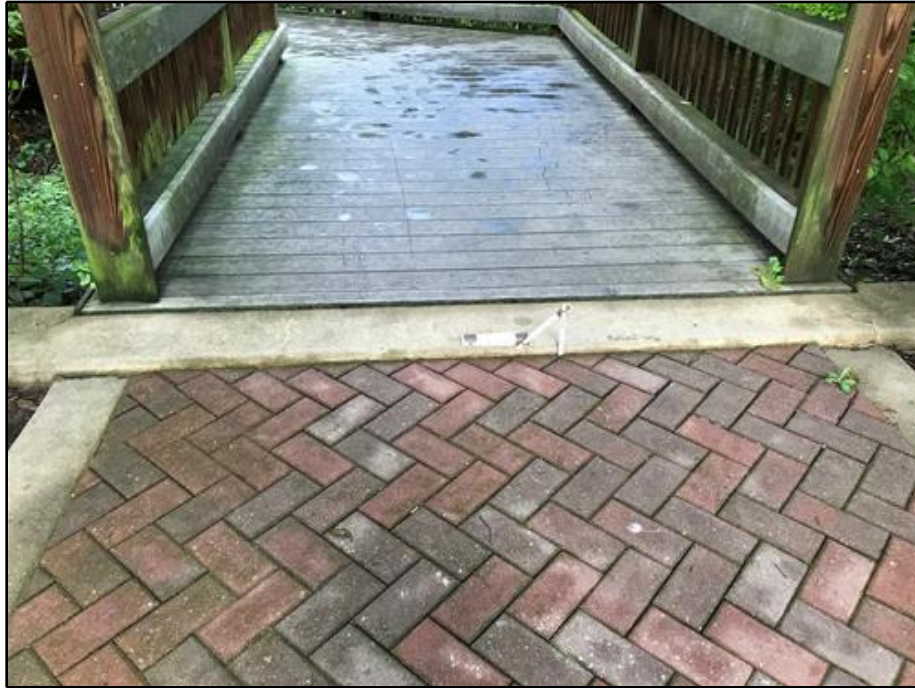
11. South Approach Walkway Transition Approximately 1 1/2" settled from Concrete Backwall

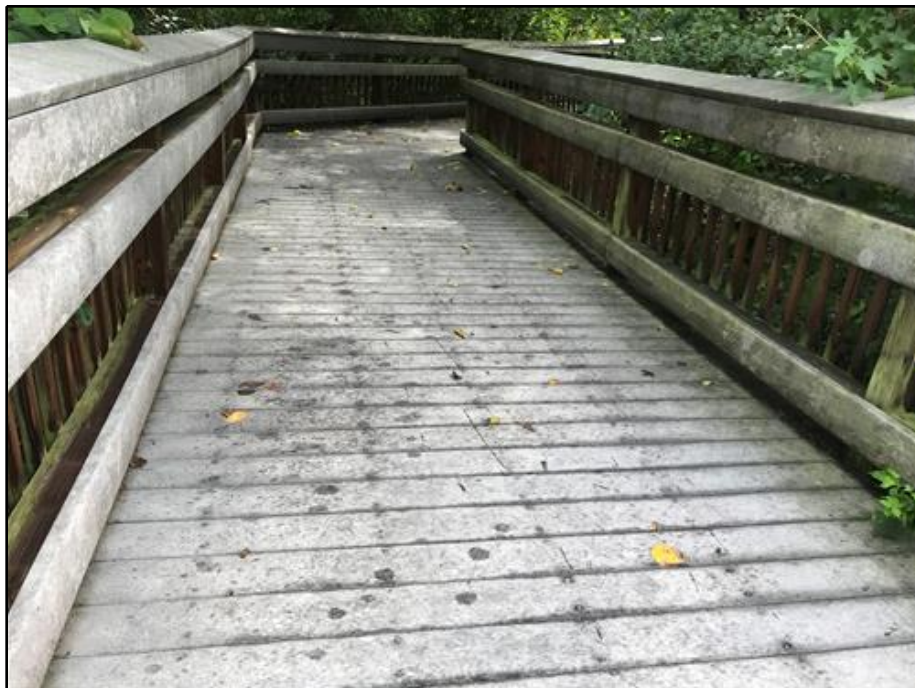
The composite lumber deck is typically in good condition. The timber deck and timber railing have been lined with composite materials and they are in good condition (see Photographs 12-15). Typically, there are gaps up to 1" open at the top corner of the railings (see Photograph 16). The timber railing posts exhibit typical checking and splintering at the south end of the east railing corner of the bridge. The 9th Post from the south end of the east railing exhibits up to a 1 1/2" open split approximately 14" long (see Photograph 17). There is a loose baluster at the east railing, 10th Post from the south end of the east railing (see Photograph 18). The base rail at the 7th post from north end of the east railing is broken and missing a 1'-8" long section (see Photograph 19). Both railings are crooked. Ice pick penetration in the timber railings is up to 3/4"±. There is minor algae growth throughout the structure. There is minor debris on the topside of the structure, especially at the south end. The underside of the deck is in good condition (see Photograph 20).

12. Main Span View of Deck Looking South

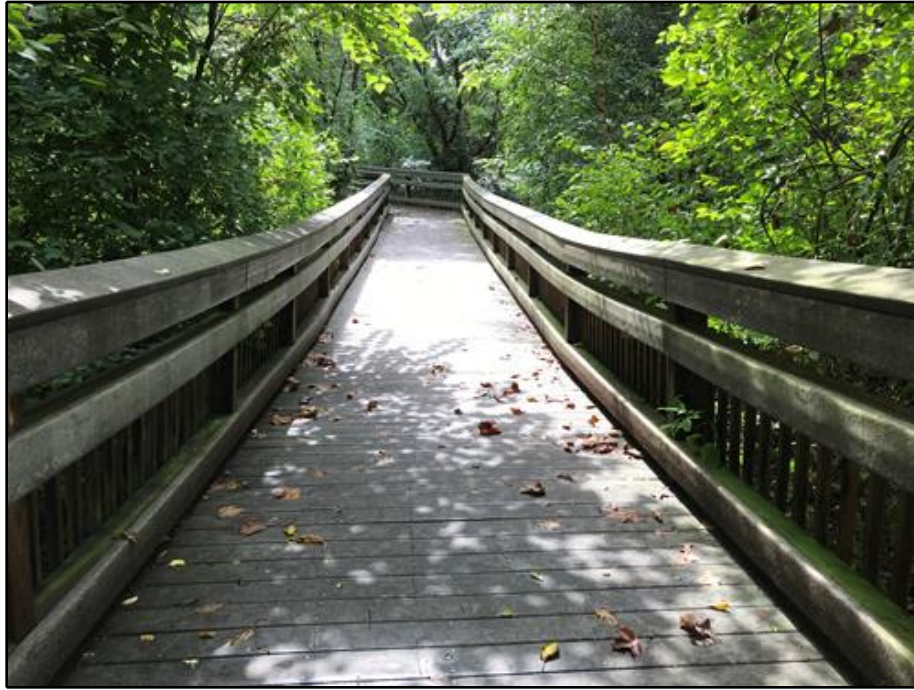
13. General Deck View Looking North

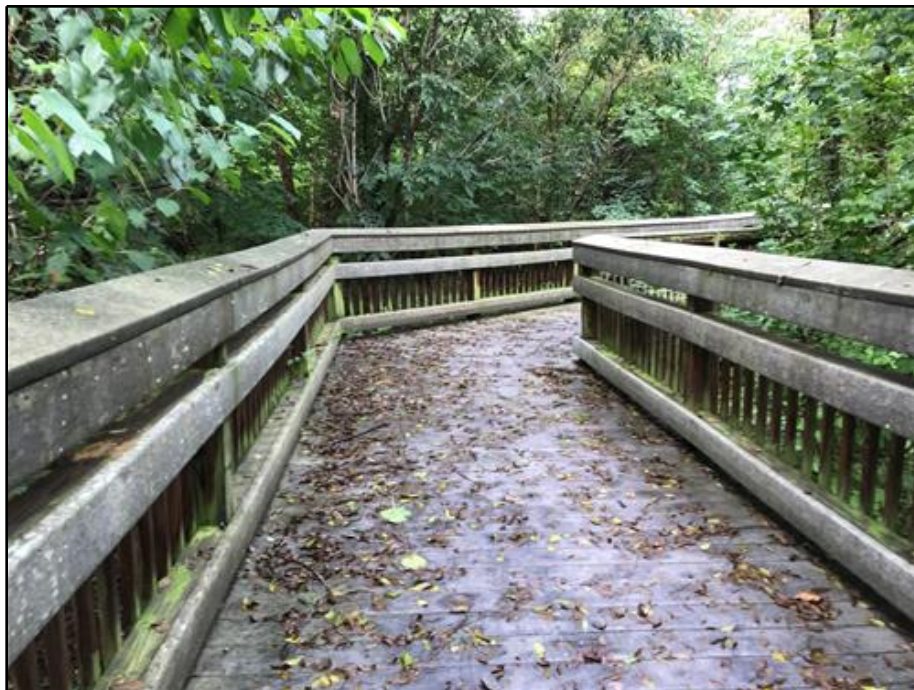
14. General View of Deck at the South end

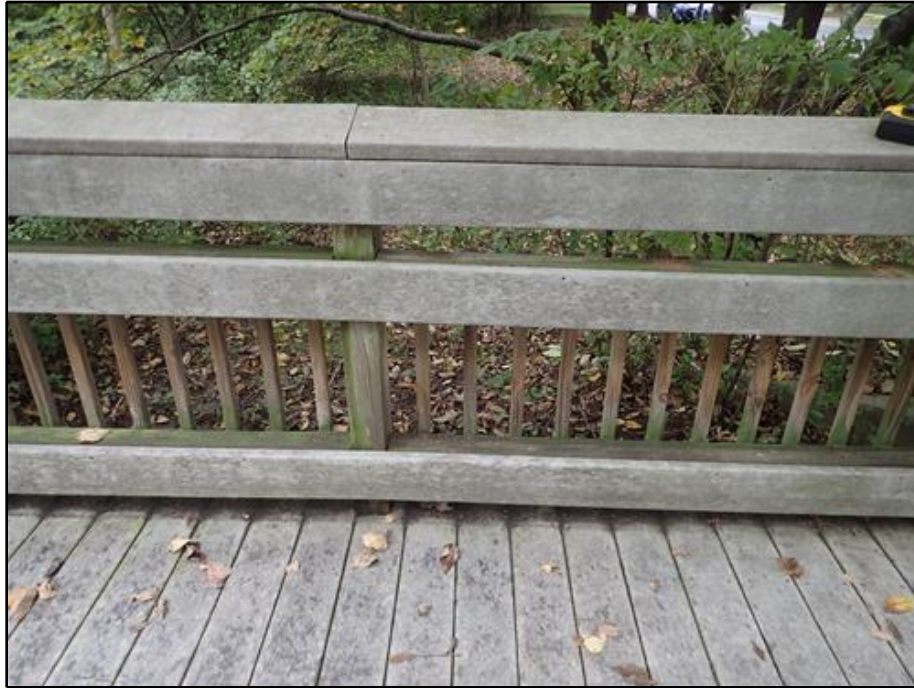
AASHTO requires that pedestrian bridge railings have a minimum height above the deck of 3'-6" and do not allow an 6" sphere to pass through the railing openings at any location. This railing system meets both criteria.

15. Typical View of Railings

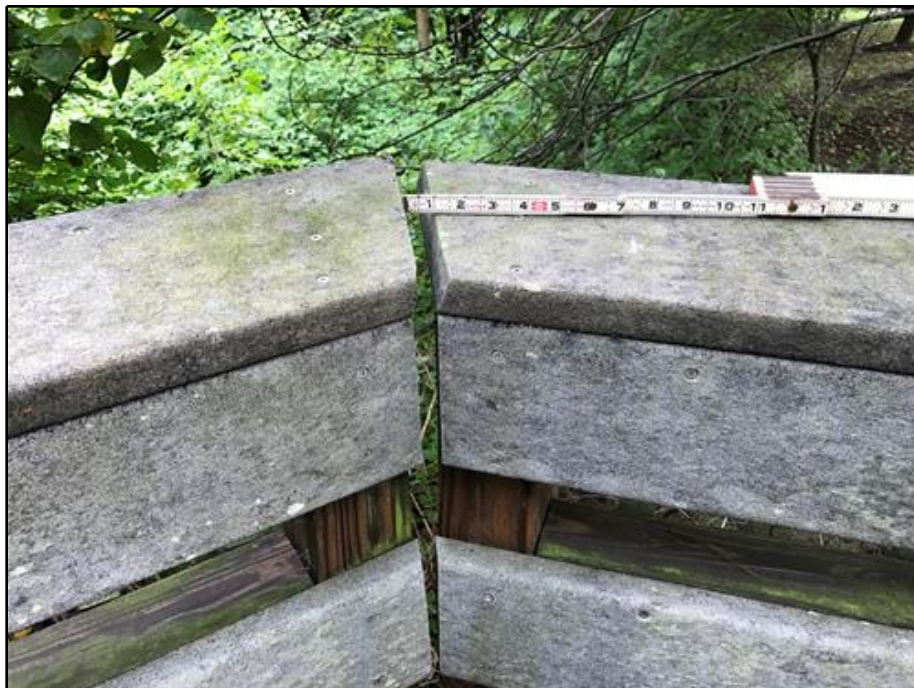
16. Typical Top Railing Gap Approximately 1" Separated

58.8 Typically, there are gaps up to 1" open at the top corner of the railings. The timber railing posts exhibit typical checking and splintering at the south end of the east railing corner of the bridge. The 9th Post from the south end of the east railing exhibits up to a 1 1/2" open split approximately 14" long. There is a loose baluster at the east railing, 10th Post from the south end of the east railing. The base rail at the 7th post from north end of the east railing is broken and missing a 1'-8" long section. Both railings are crooked. Ice pick penetration in the timber railings is up to 3/4"±.

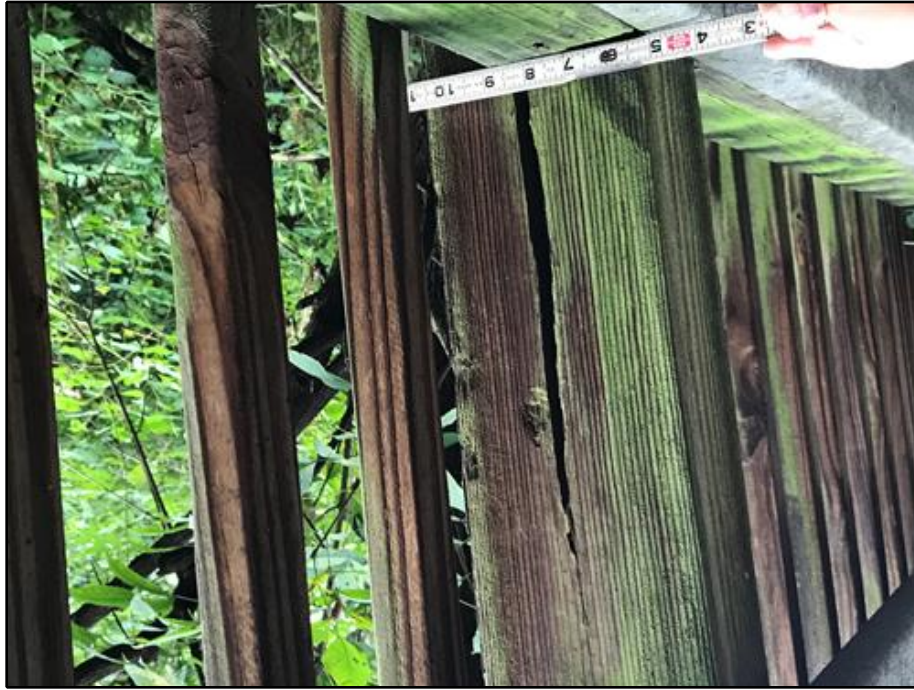
17. Up to 1 1/2" Open Split in 9th Wood Post from the South End of the East Railing

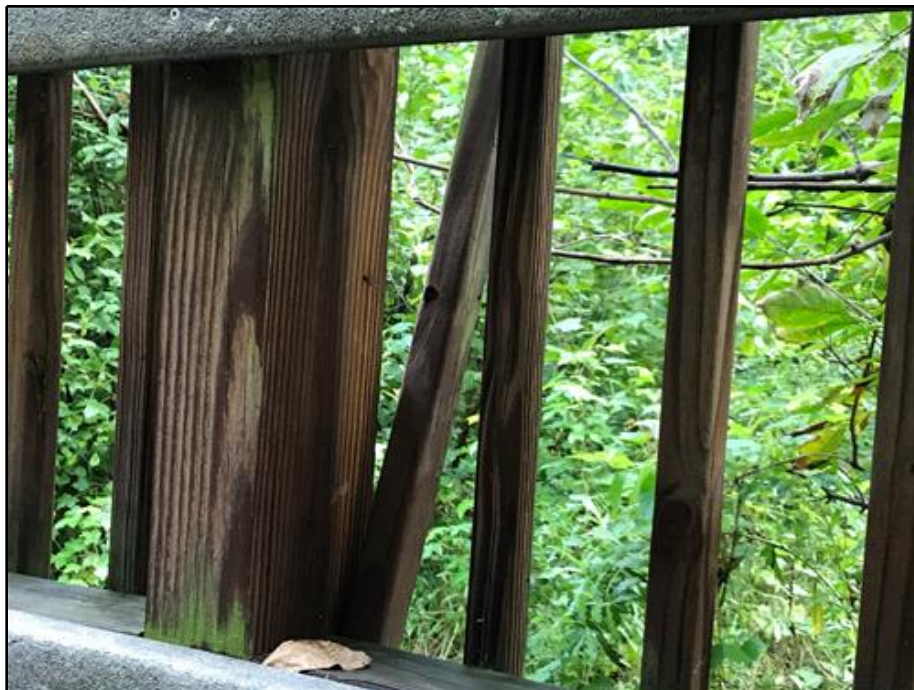
18. Loose Balustrade Adjacent to 10th Post from the South End of East Railing

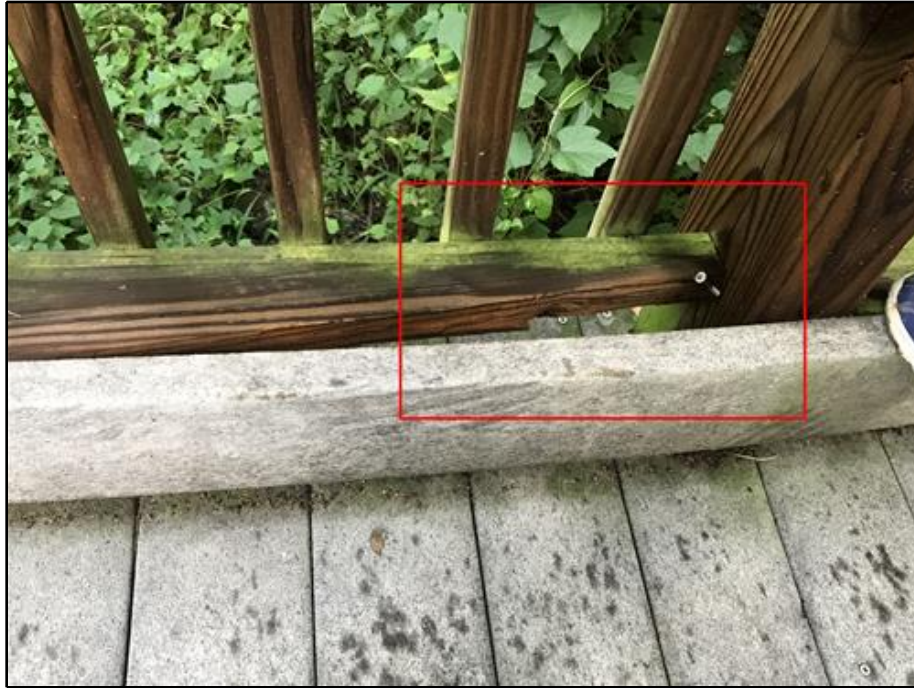
19. Broken Base Rail at 7th Post from North End of East Railing

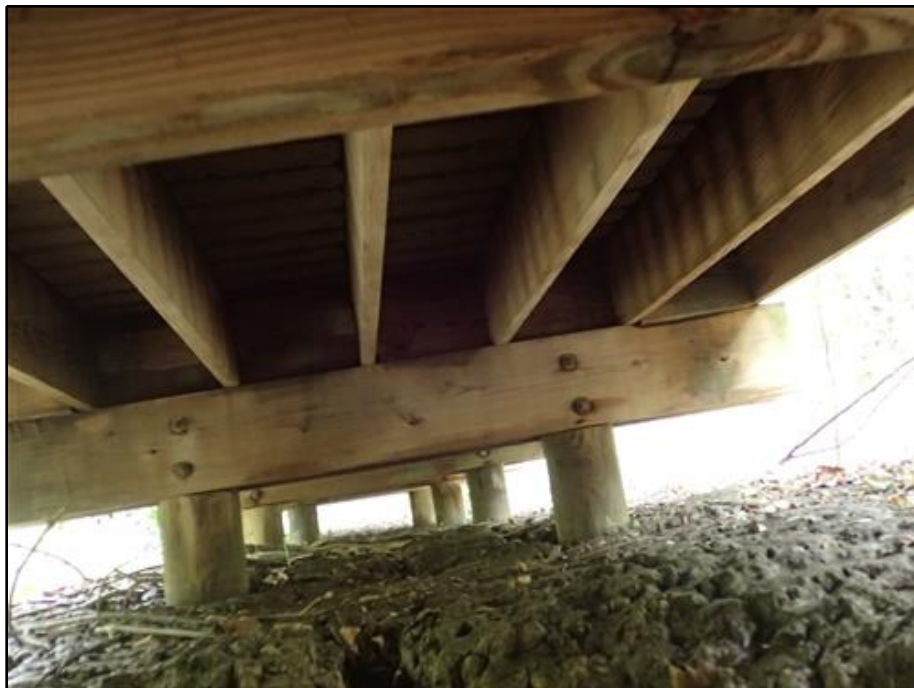
The timber beams are in good condition (see Photograph 20). There is a 3'-0" long x 1/4" open splinter in the fascia board at the west side of span 14 (see Photograph 21). Typically, the 7" high x 3/4" thick and 6" high x 2" thick fascia boards, there are up to 1/4" pick penetration. At the east side of Span 15, there is an approximately 4" diameter tree growing from the underside (see Photograph 22). At the west side of Span 12, the fascia board is misaligned approximately 3/16" out. Both timber fasciae exhibit typical checking, deterioration, and splitting.

20. Typical View of Underside

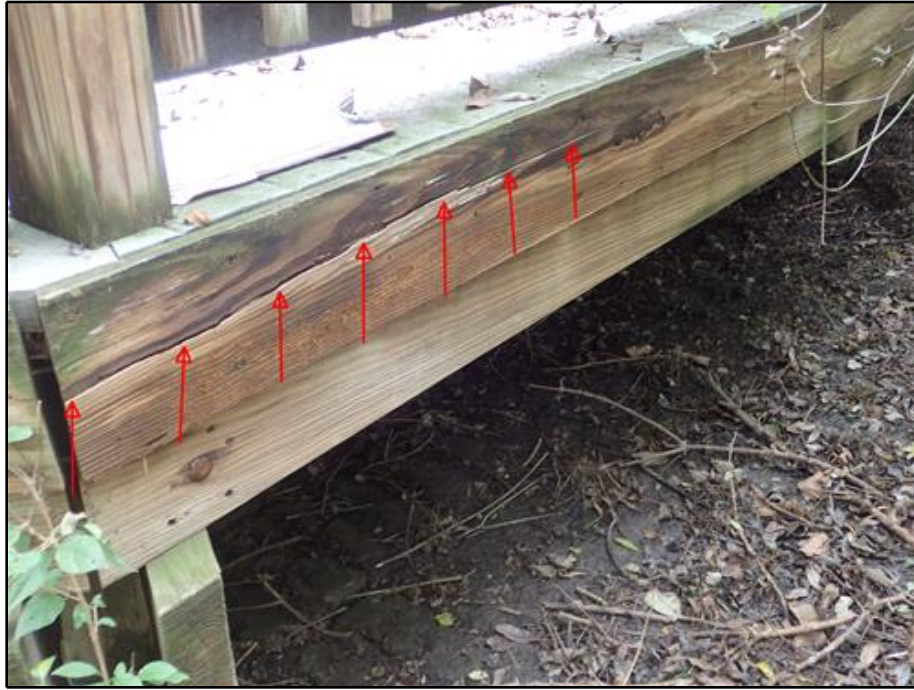
21. 3'-0" Long x 1/4" Open Splintering in Fascia Board at the West Side of Span 14

The timber beams are in good condition. There is a 3'-0" long x 1/4" open splinter in the fascia board at the west side of span 14. Typically, the 7" high x 3/4" thick and 6" high x 2" thick fascia boards, there are up to 1/4" pick penetration. At the east side of Span 15, there is an approximately 4" diameter tree growing from the underside. At the west side of Span 12, the fascia board is misaligned approximately 3/16" out. Both timber fasciae exhibit typical checking, deterioration, and splitting.

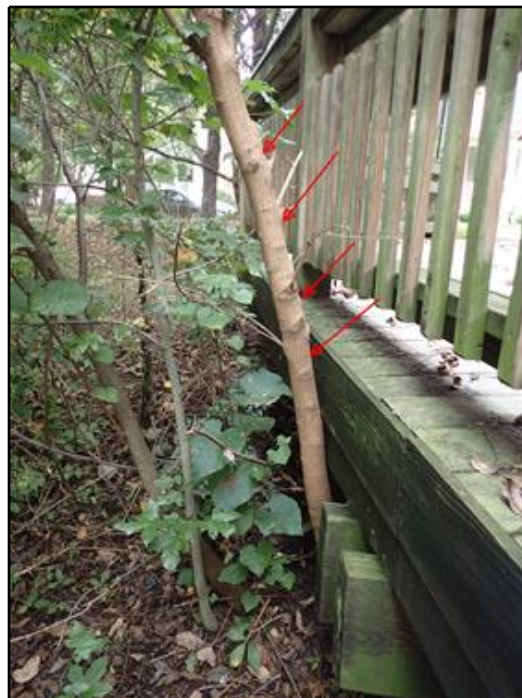
22. Approximately 4" Diameter Tree Growing under East Side of Span 15

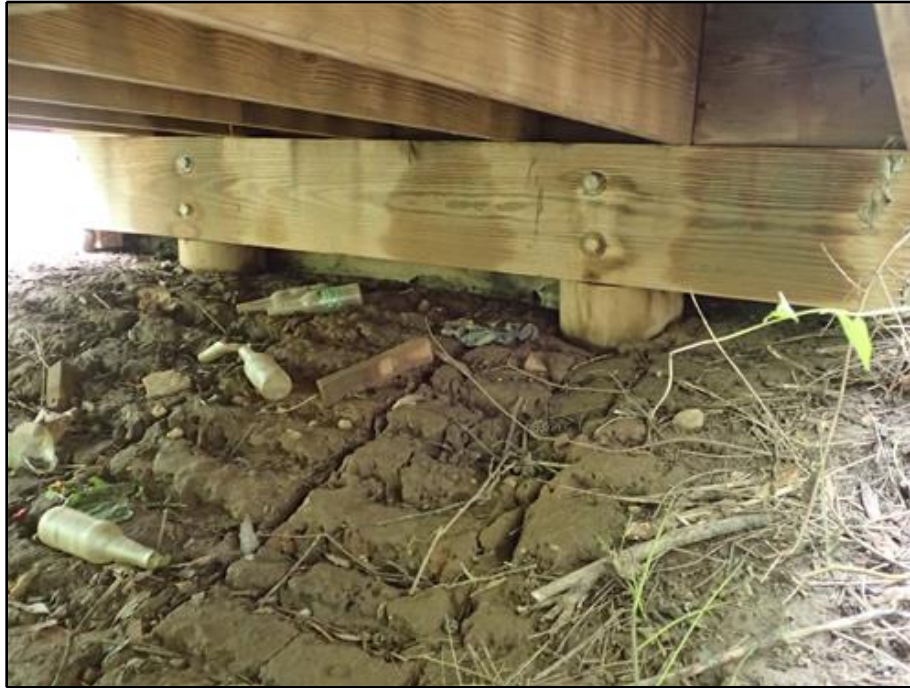
The faces of both abutments are covered with planks, so they could not be inspected. However, the visible portions appear to be in good condition (see Photographs 23 and 24). There are hairline cracks with efflorescence at the top of both abutment backwalls (see Photographs 10 and 11). The wing walls are in good condition. There is vegetation growth and minor debris around the wing wall (see Photograph 25).

23. Overall View of North Abutment

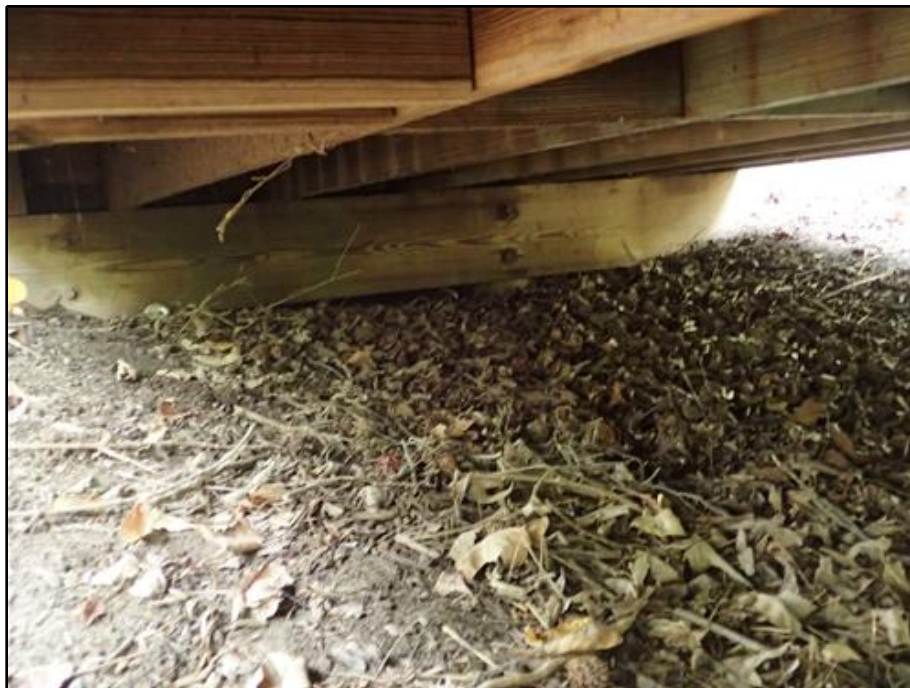
24. South Abutment View From East

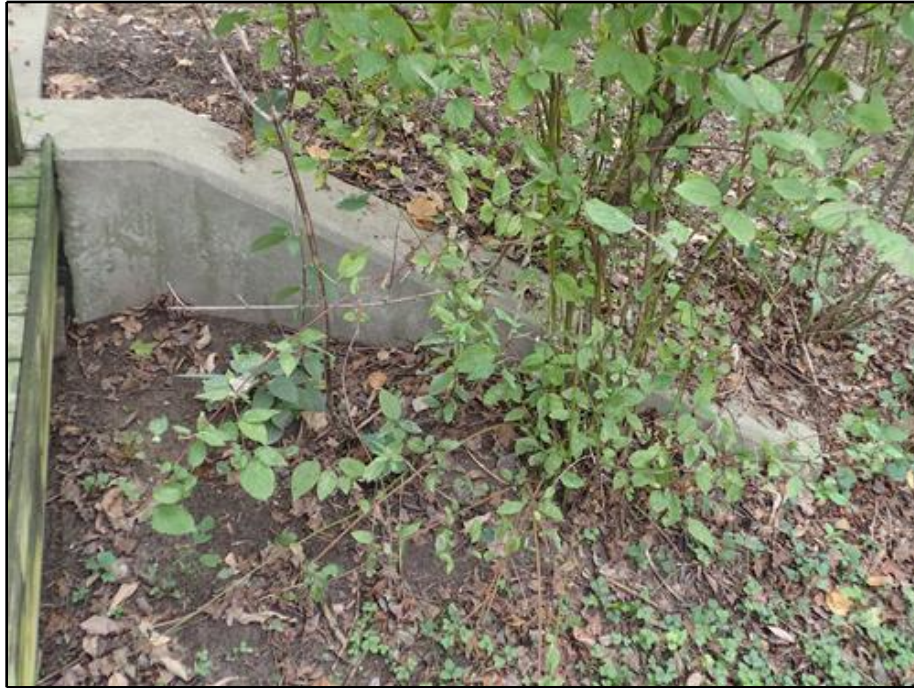
25. Typical View of Wing Wall (Southwest Wing Wall Shown)

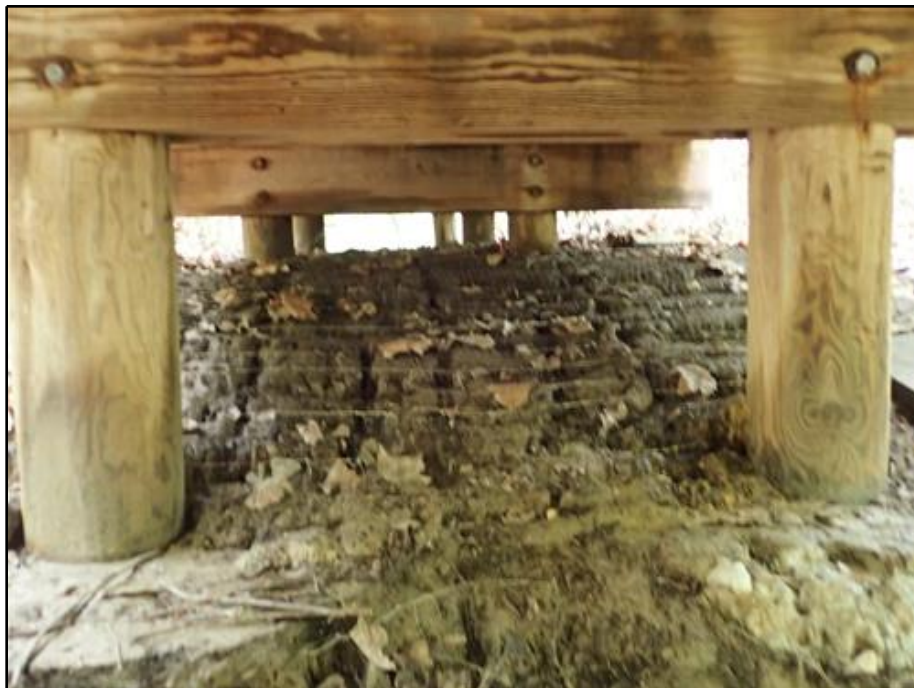
The timber piles, pile caps, and diaphragms are in good condition. Typically, there is checking of the timber piles, pile caps, and diaphragms (see Photographs 26 and 27). There are two rot sections approximately 3" high x 2" wide x up to 3/4" of pick penetration in the west Pile at Bent 10 (see Photographs 28 and 29). Also, there is a 10' long section of erosion around this pier between spans 9 and 10 (see Photograph 30).

26. Typical View of Piles

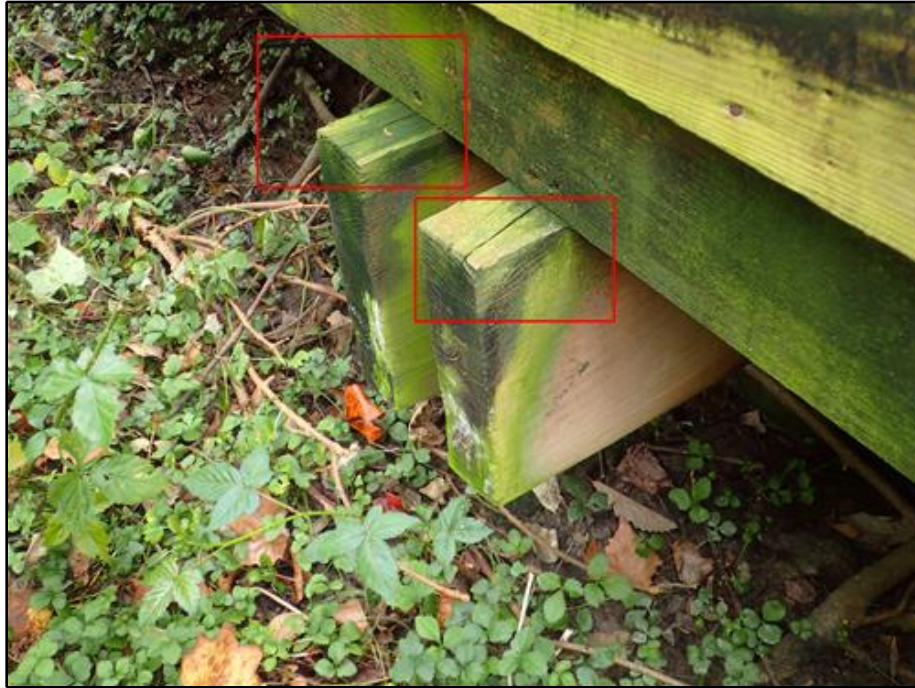
27. Typical Checks in Top of Timber Pile Caps (Bent 13 Shown)

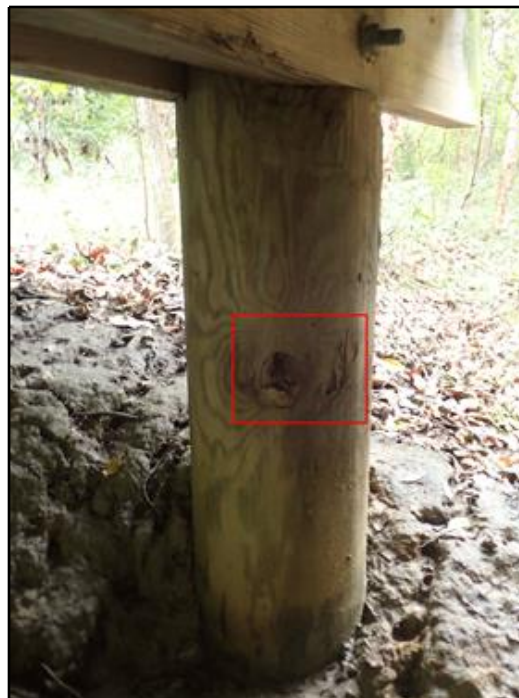
28. Approximately 3" High x 2" Wide x Up to 3/4" Pick Penetration Rot in west Pile at Bent 10

60.2 The timber piles, pile caps, and diaphragms are in good condition. Typically, there is checking of the timber piles, pile caps, and diaphragms. There are two rot sections approximately 3" high x 2" wide x up to 3/4" of pick penetration in the west Pile at Bent 10. Also, there is a 10' long section of erosion around this pier between spans 9 and 10.

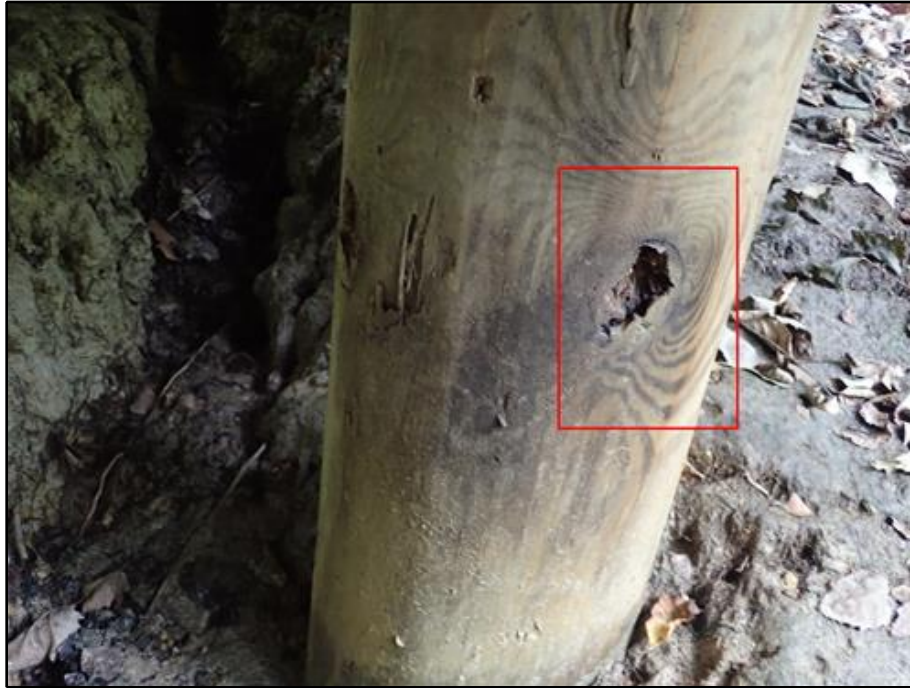
29. Approximately 3" High x 2" Wide x Up to 3/4" Pick Penetration Rot in west Pile at Bent 10

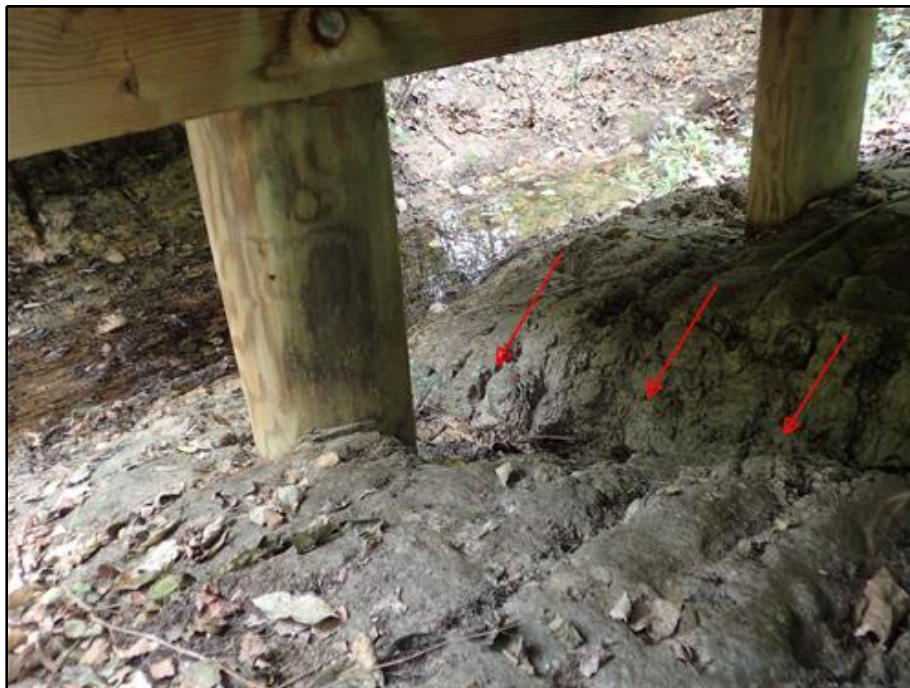
Good	10' long section of erosion around the pier between spans 9 and 10.
Channel

30. Erosion in Span 9 and 10 Leading to Channel Up to 10 Feet Long
